THE EFFECTS OF TROPICAL STORM IRENE ON THE WINOOSKI HEADWATERS: *Physical and Chemical Characteristics and Changes*

Kassandra Morse, Ashley Maurice, David Schilling
Cabot High School
Cabot, Vermont

ABSTRACT AND GUIDING QUESTION

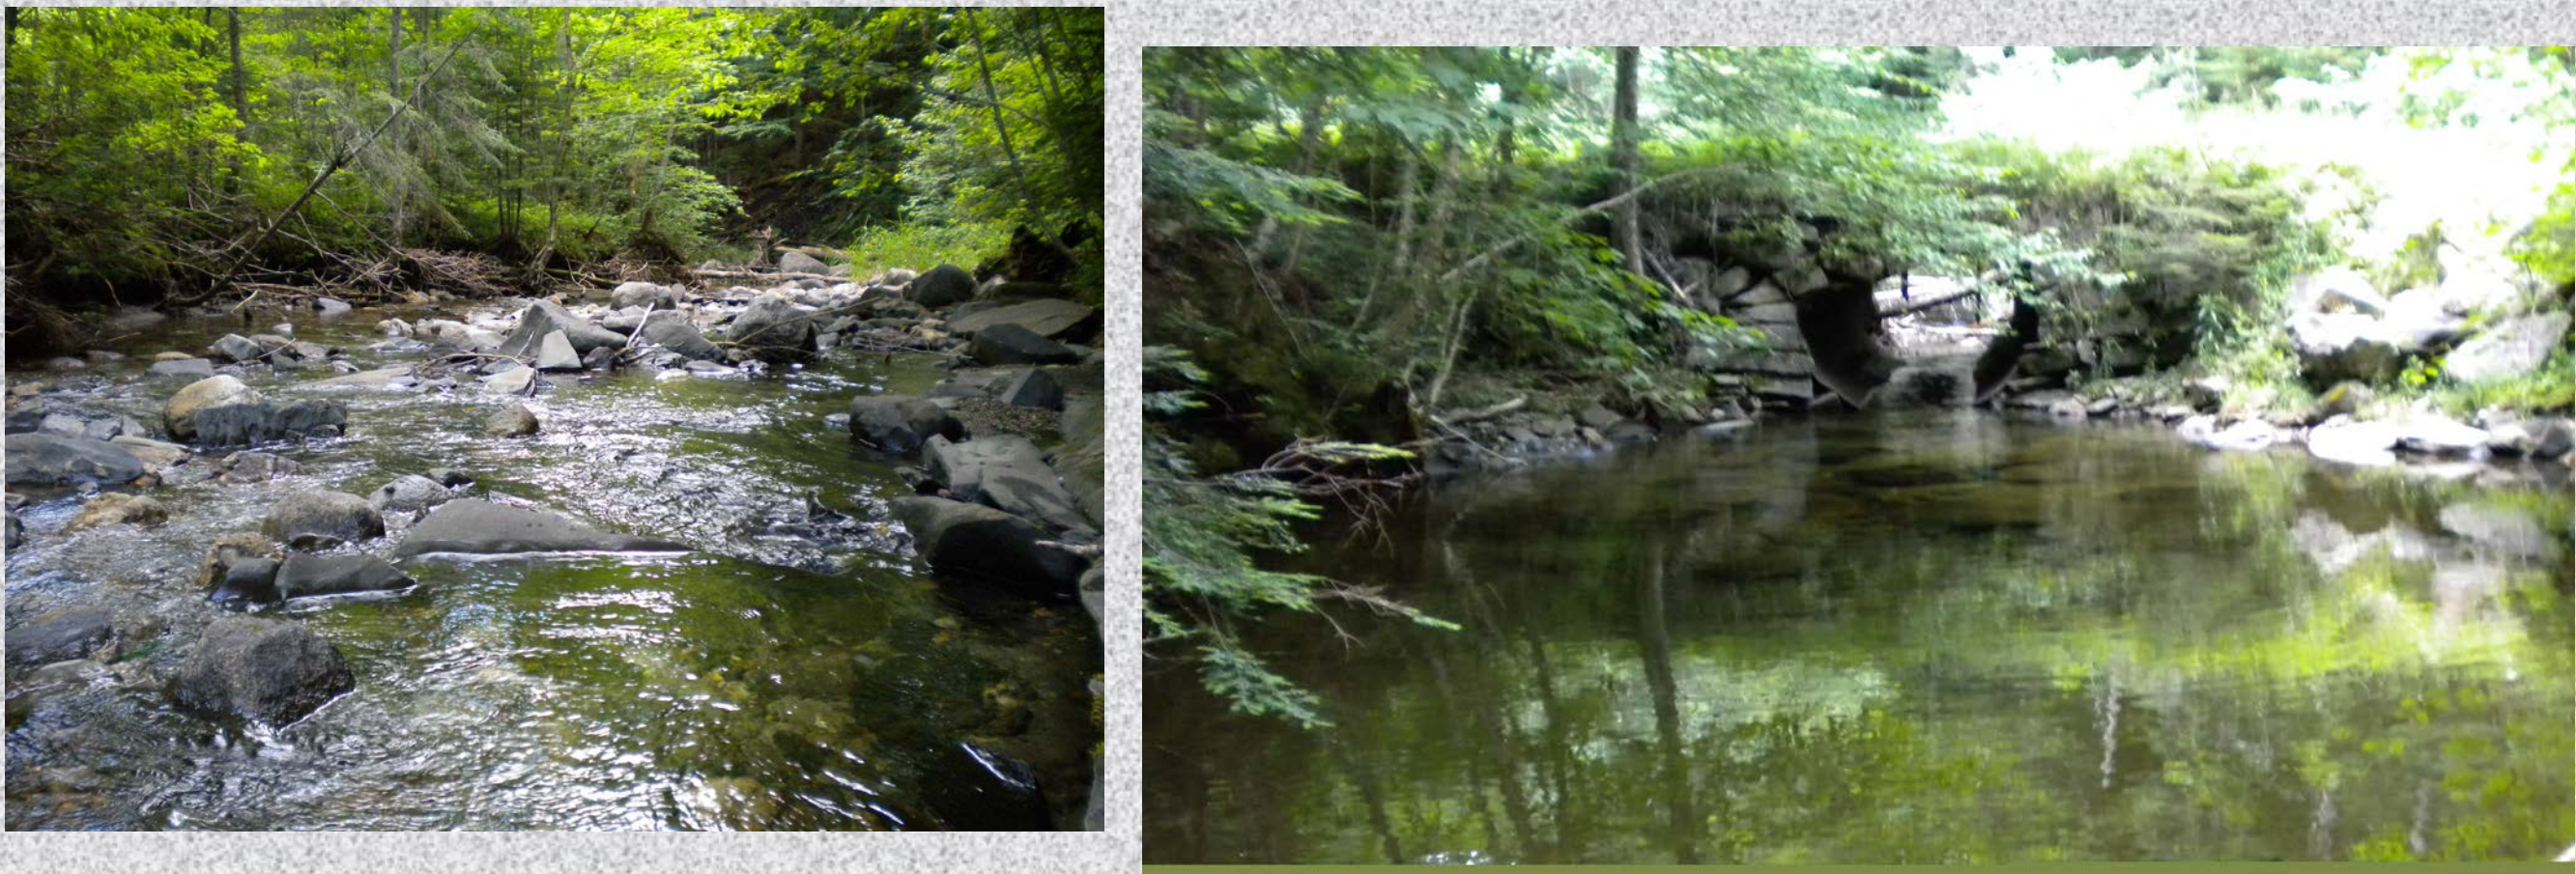
The Jug Brook site was certainly off the beaten path. In order to get to it, it was necessary to trek through several meters of undergrowth and mud. Once there, it was a lovely area. The stream went through a culvert about 9 meters before the actual site. The culvert guided the stream under a rural dirt road. The actual 6 meter reach of our attention was shallow and filled with rocks, which disrupted the stream flow, creating 'riffles' or ripples in the water; ideal habitat for macroinvertebrates.

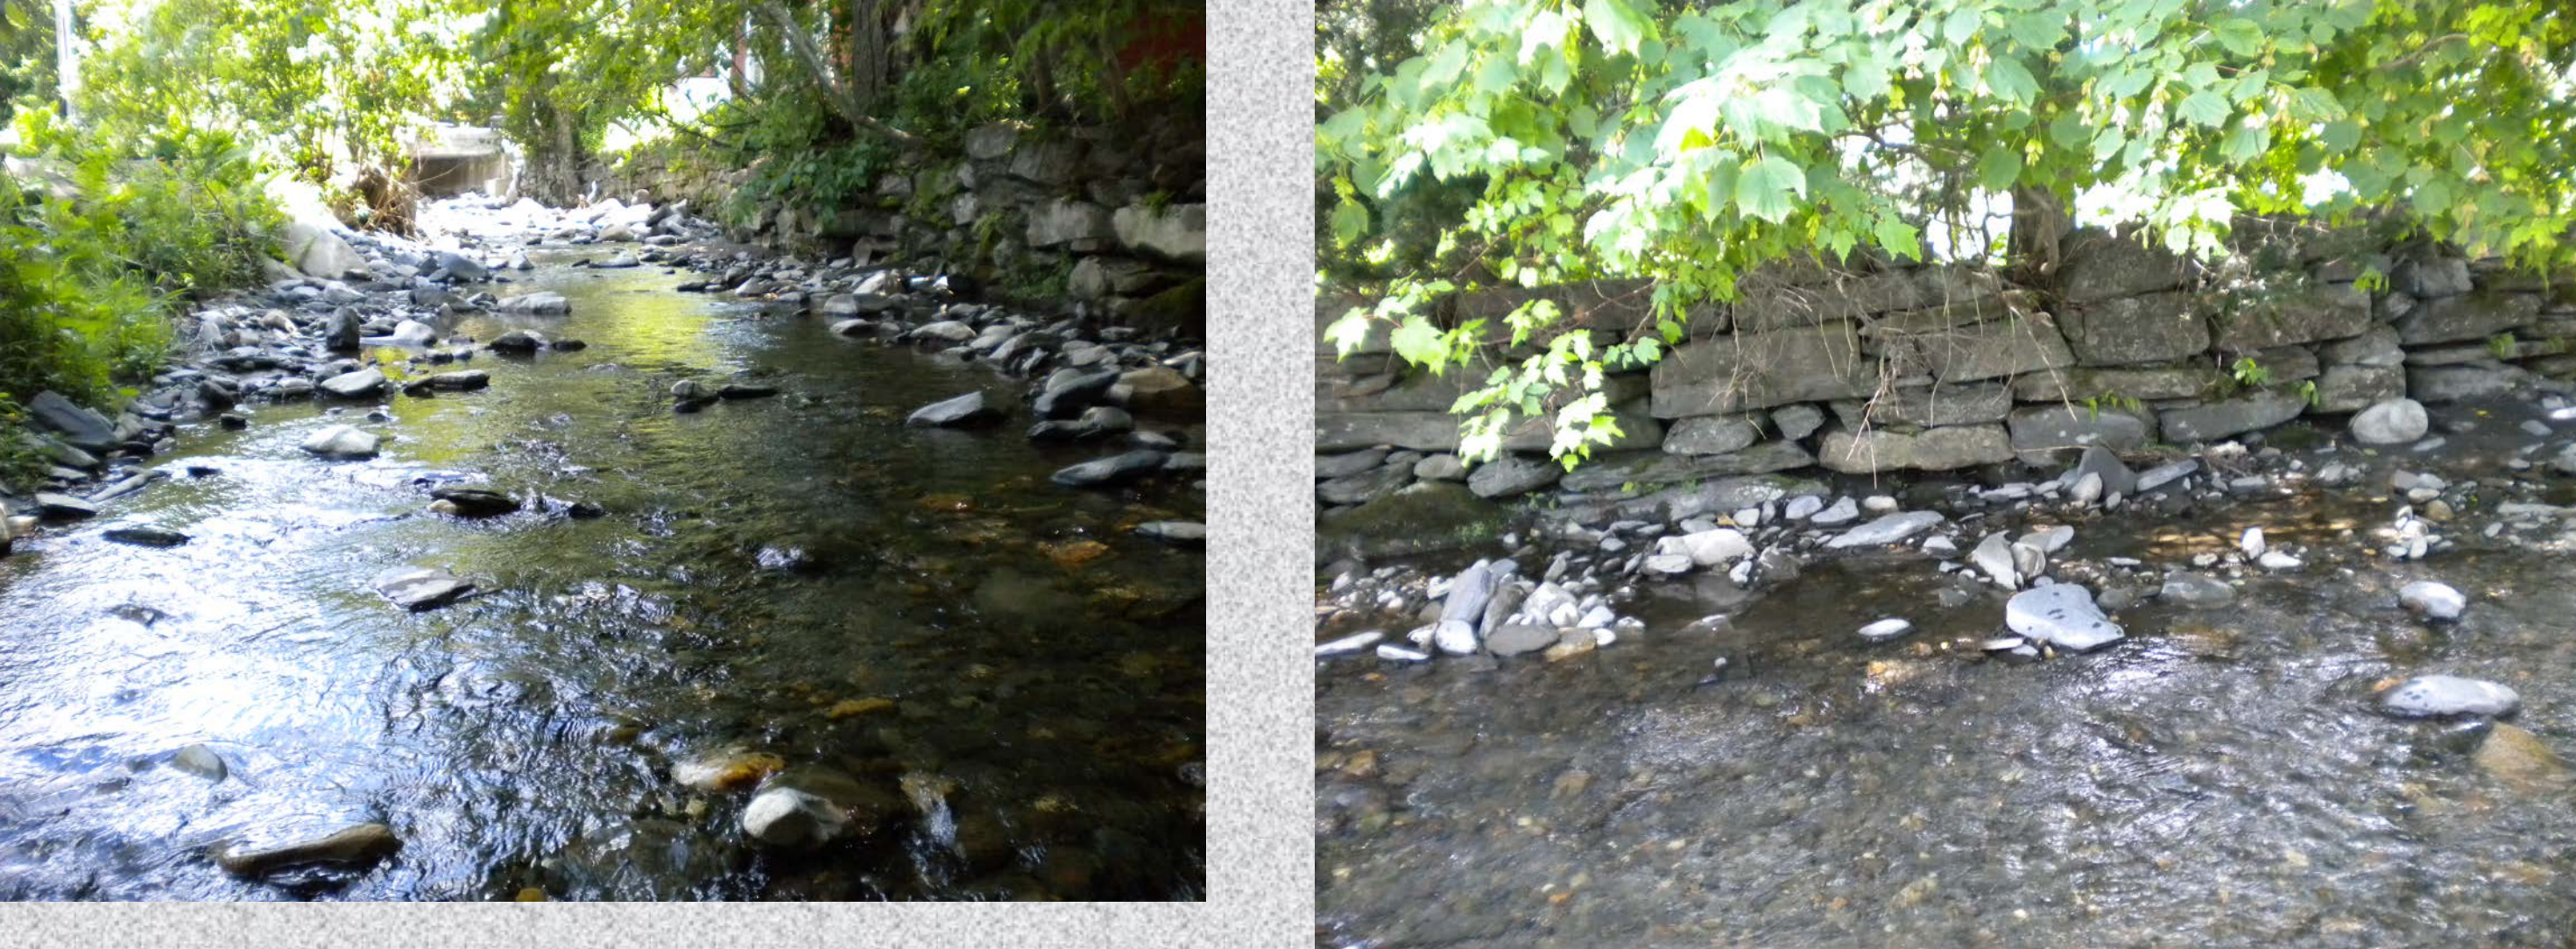
The Winooski River site is immediately adjacent to the Cabot town recreation field, and is a popular swimming and picnicking place. The river is shallow and filled with riffles. The canopy cover is total and the river has been disrupted frequently by young dam-builders keen on cooling off during the summer. Most of the rocks were embedded into the bottom of the stream, which meant that the stream wasn't as healthy as the Jug Brook site; as the macroinvertebrates didn't have a place they could crawl under to hide. We hypothesize that this compaction is due to the impact of many young feet in the stream over the course of the summer.

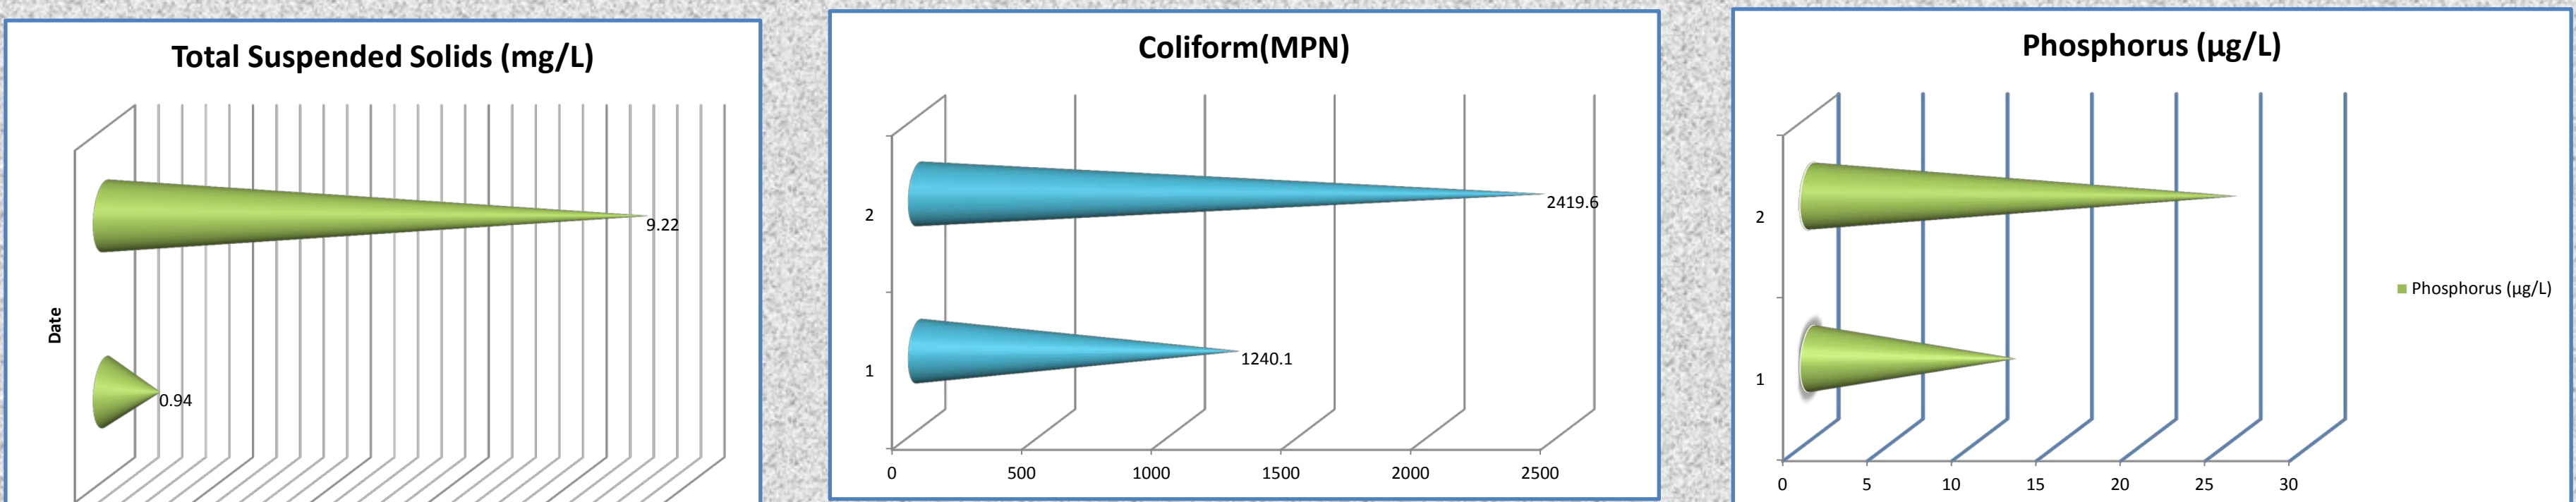
At the Winooski site, coliform bacteria averaged 1240MPN. After the storm this count doubled. This was expected, as the river flowed over several agricultural pastures on its way down into the town center.

Phosphorus levels at the Winooski site were already relatively high, around 12mg/L, attributed to the more populated location. After the storm, phosphorus levels increased by another 12mg/L, after the water had washed over conceivably every yard between the headwaters and the testing site.

After the storm, the Winooski River site was in far better shape than the Jug Brook site, as the banks of the river had been previously reinforced with stone and formed concrete to protect the residential areas from severe flooding. The walls did not help with flooding, as the water rose far past the stone wall, but did save the banks from being completely eroded away with the increased water velocity. Because most of the stones were embedded in the river, the river bottom was relatively unscathed.
