State of the Lake - 2012

Vermont EPSCoR Annual Meeting

16 August 2012
William G. Howland, LCBP Manager

STATE OF THE LAKE

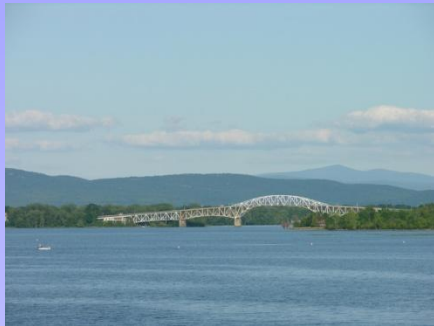
South Lake

- Exceeds P targets
- Excess weed growth
- Water chestnut and Eurasian watermilfoil
- Much of the watershed is intensively farmed

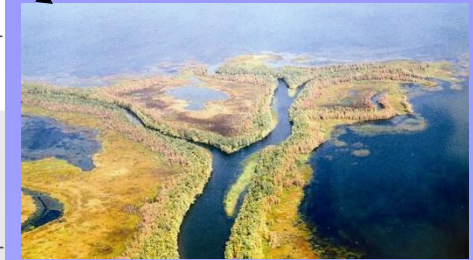
Missisquoi Bay

- Greatly exceed P target
- Seasonal BGA blooms
- Extensive agriculture

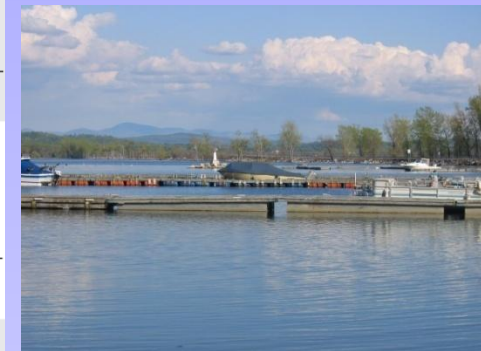
Northeast Arm

- Exceeds P targets
- Seasonal BGA blooms
- Eurasian watermilfoil
- Extensive agriculture and urban areas

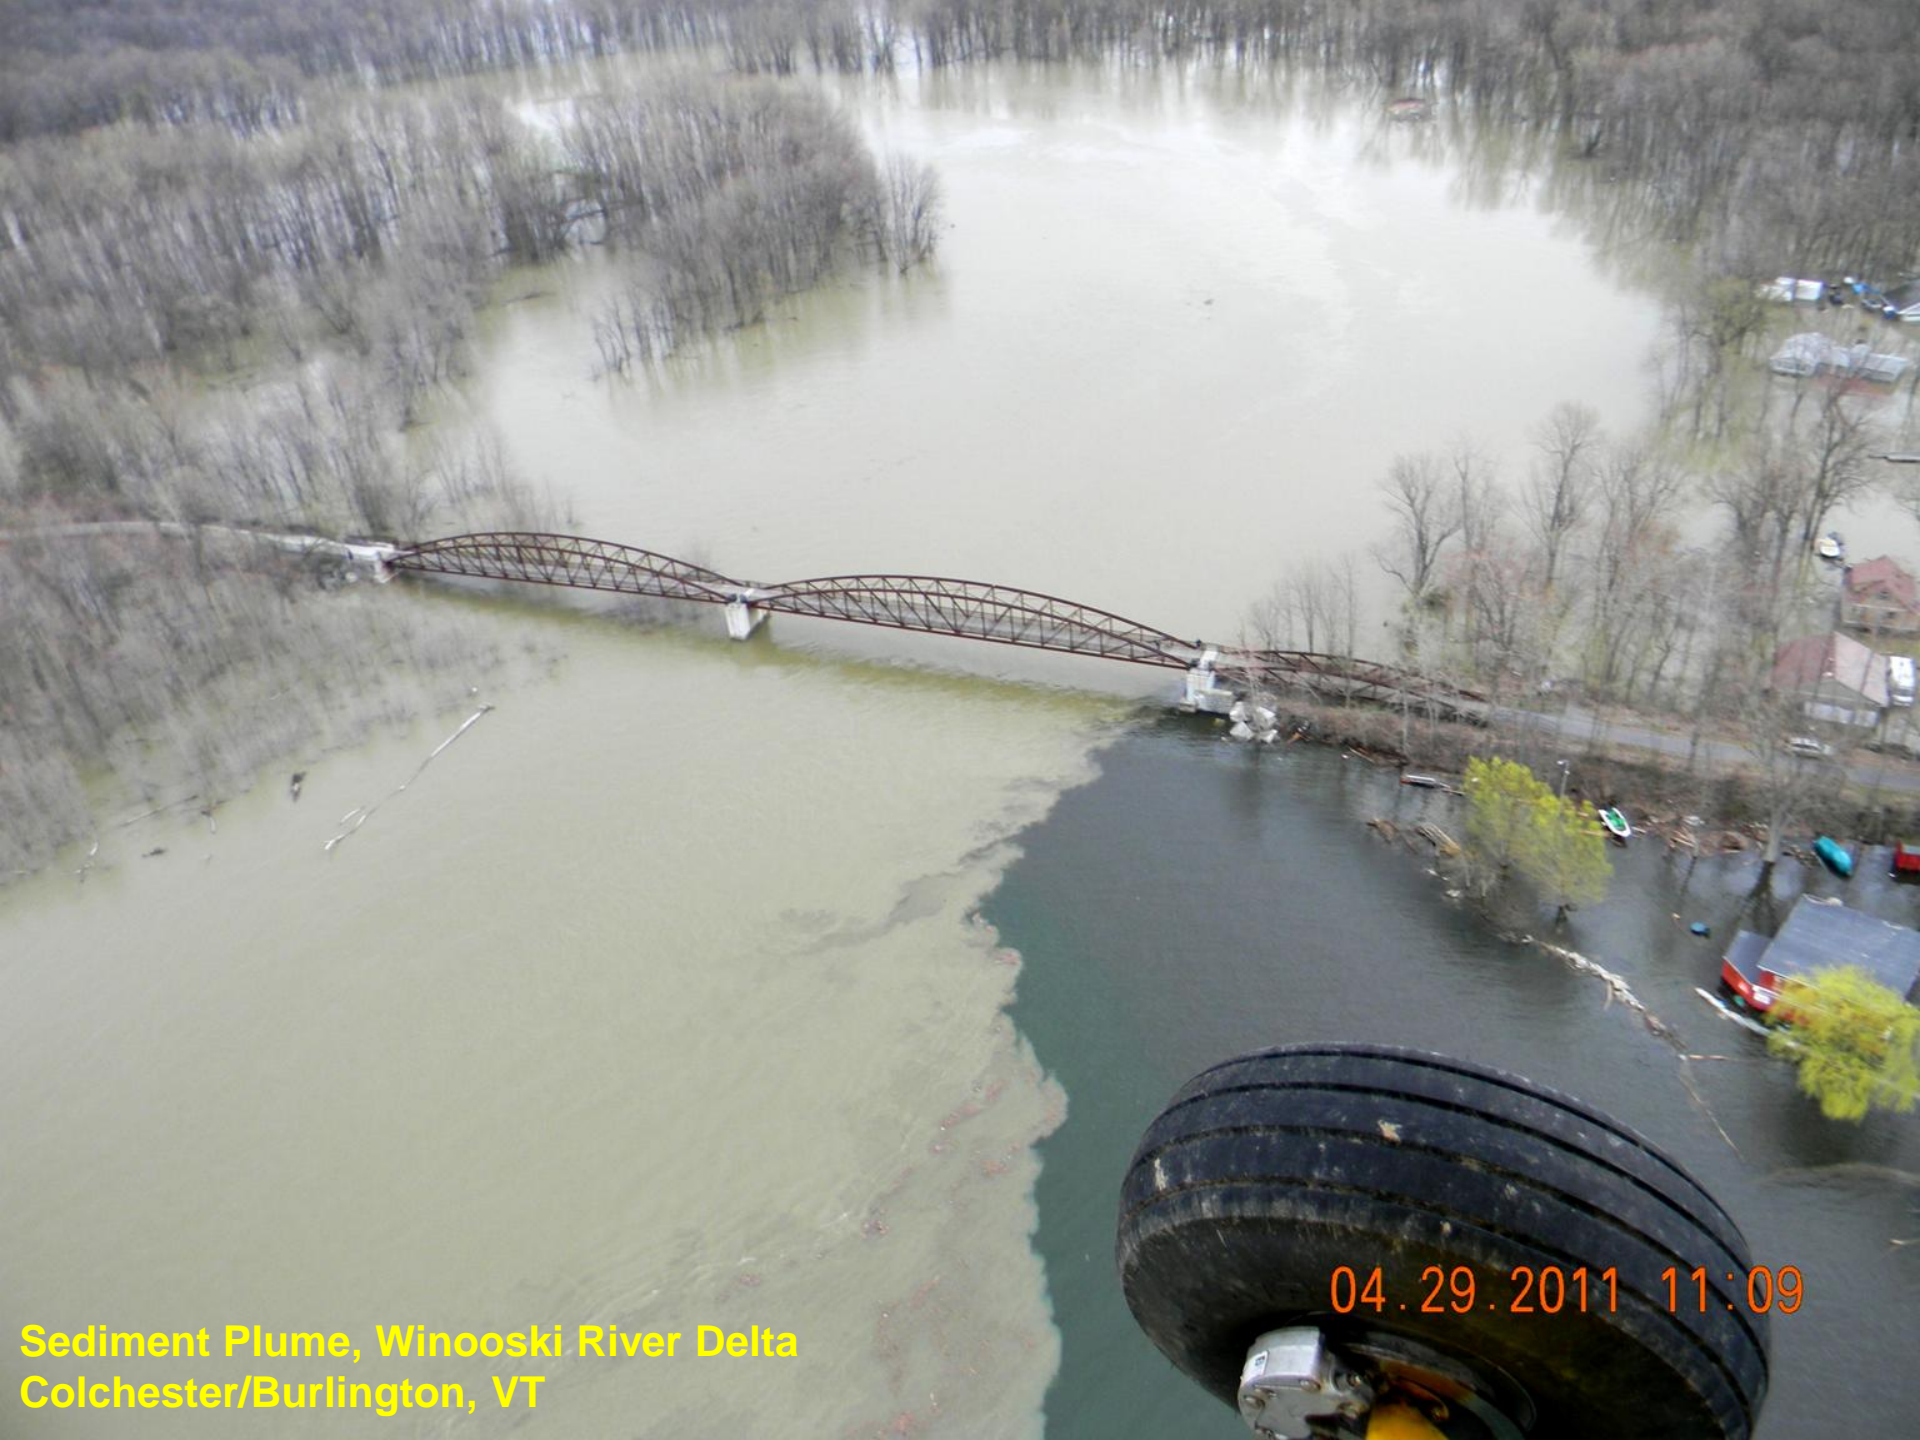
Sediment Plume, Winooski River Delta
Colchester/Burlington, VT

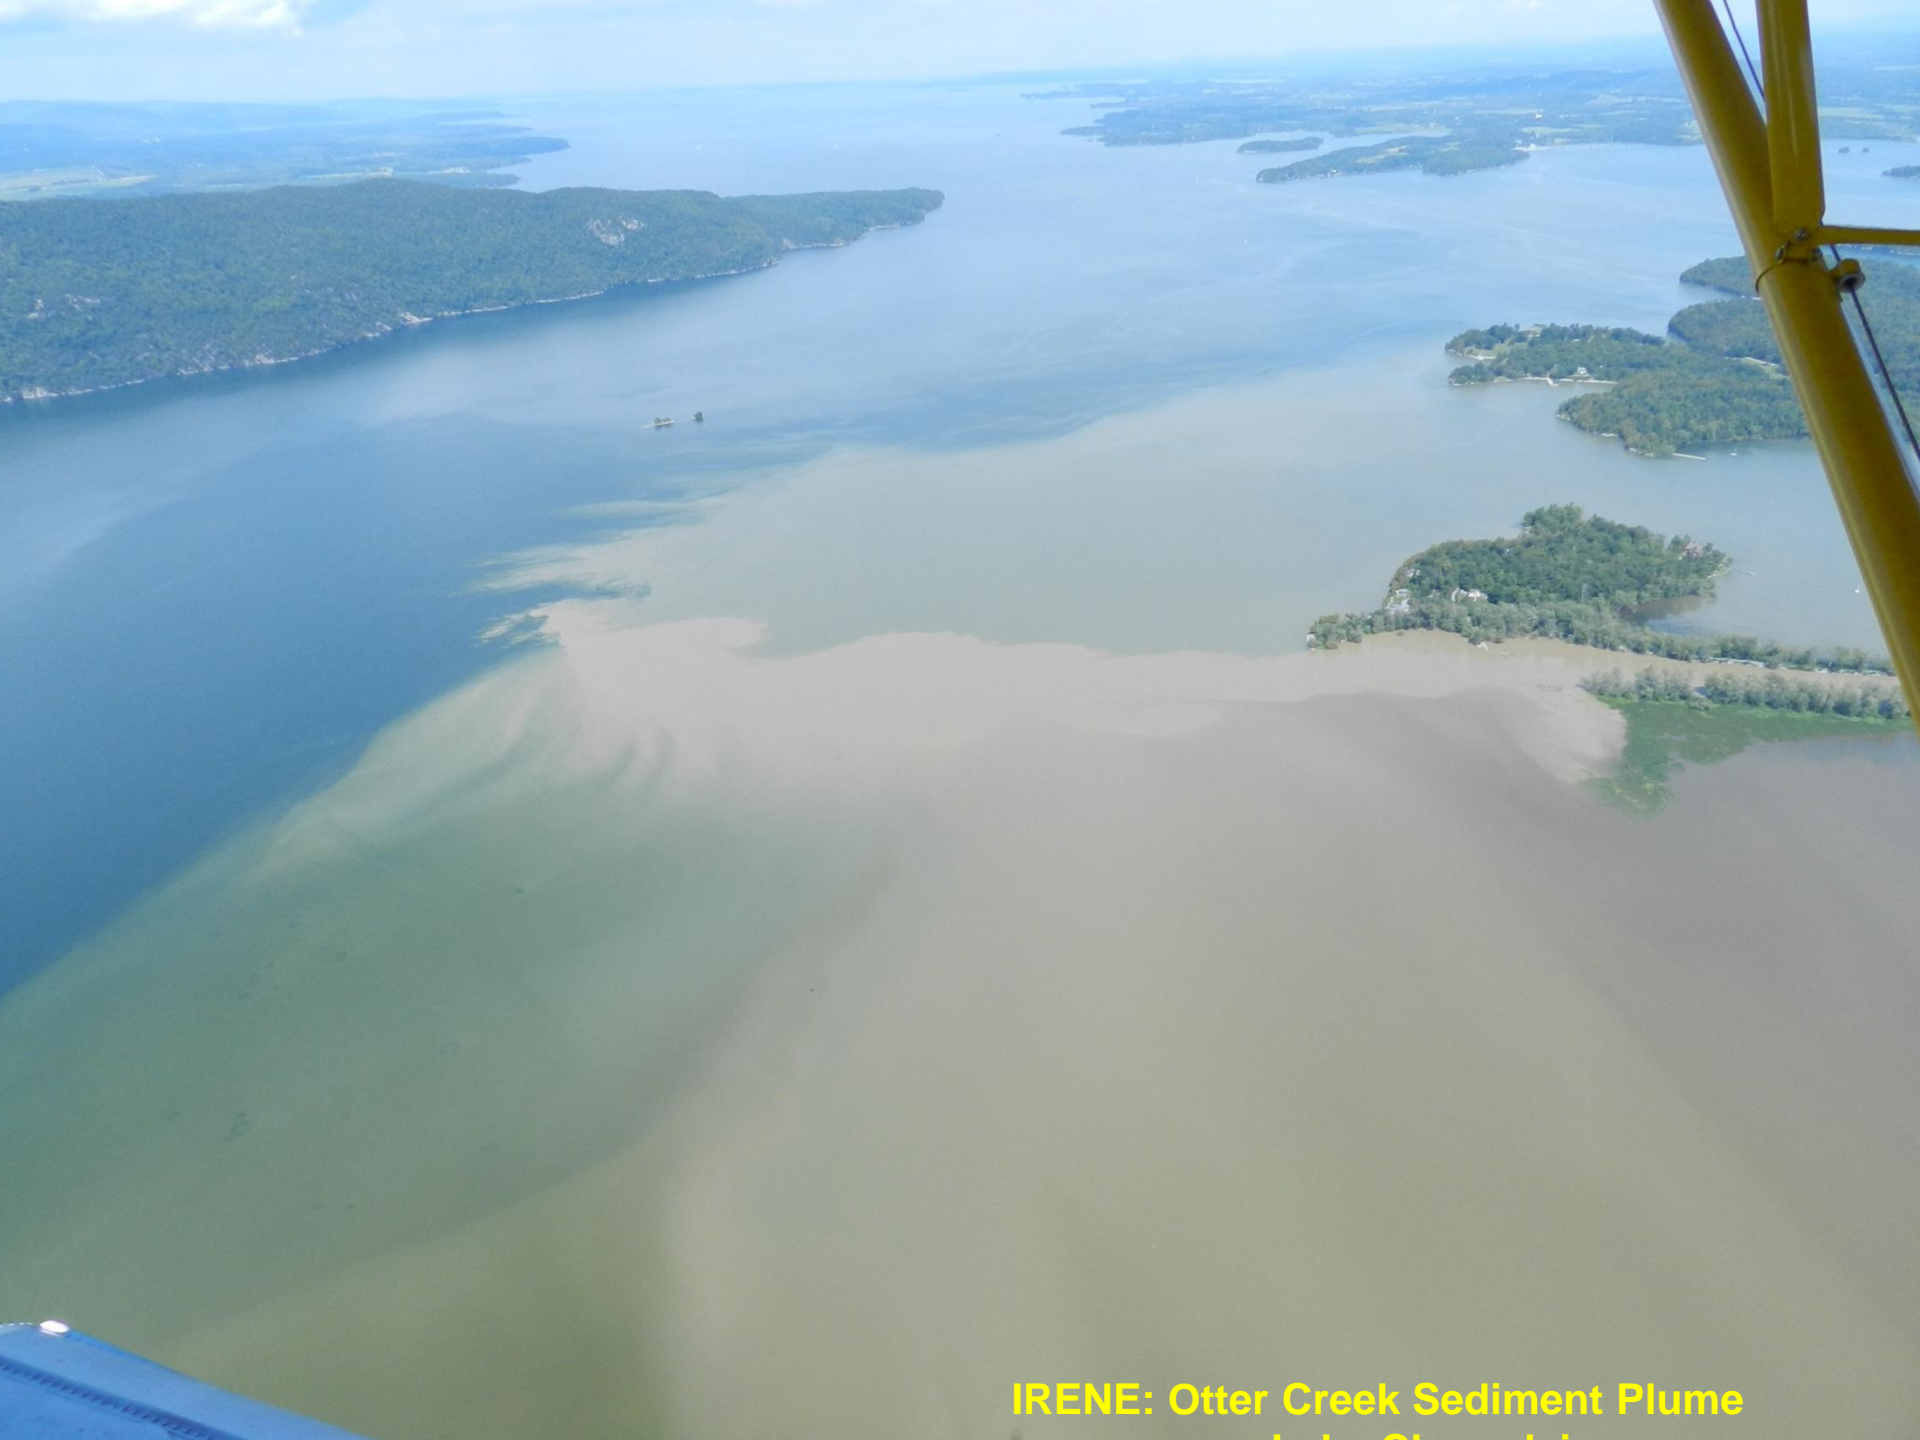
Figure 23

IRENE: Otter Creek Sediment Plume

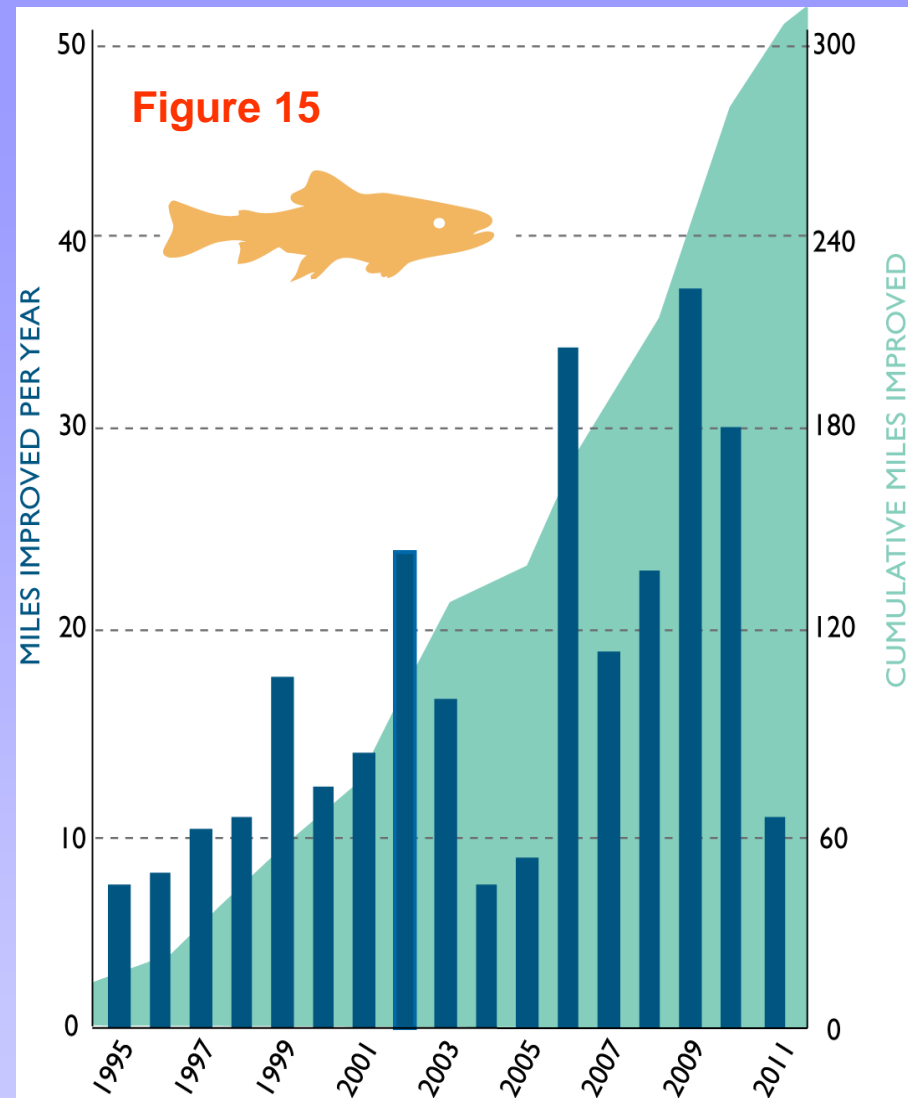
Miles of riparian habitat restored and enhanced in the Lake Champlain Basin through the U.S. Fish and Wildlife Service's Partners for Fish and Wildlife Program. Accomplishments reflect the Service's partnership with local landowners, other Federal and State agencies and numerous other non-governmental conservation groups.

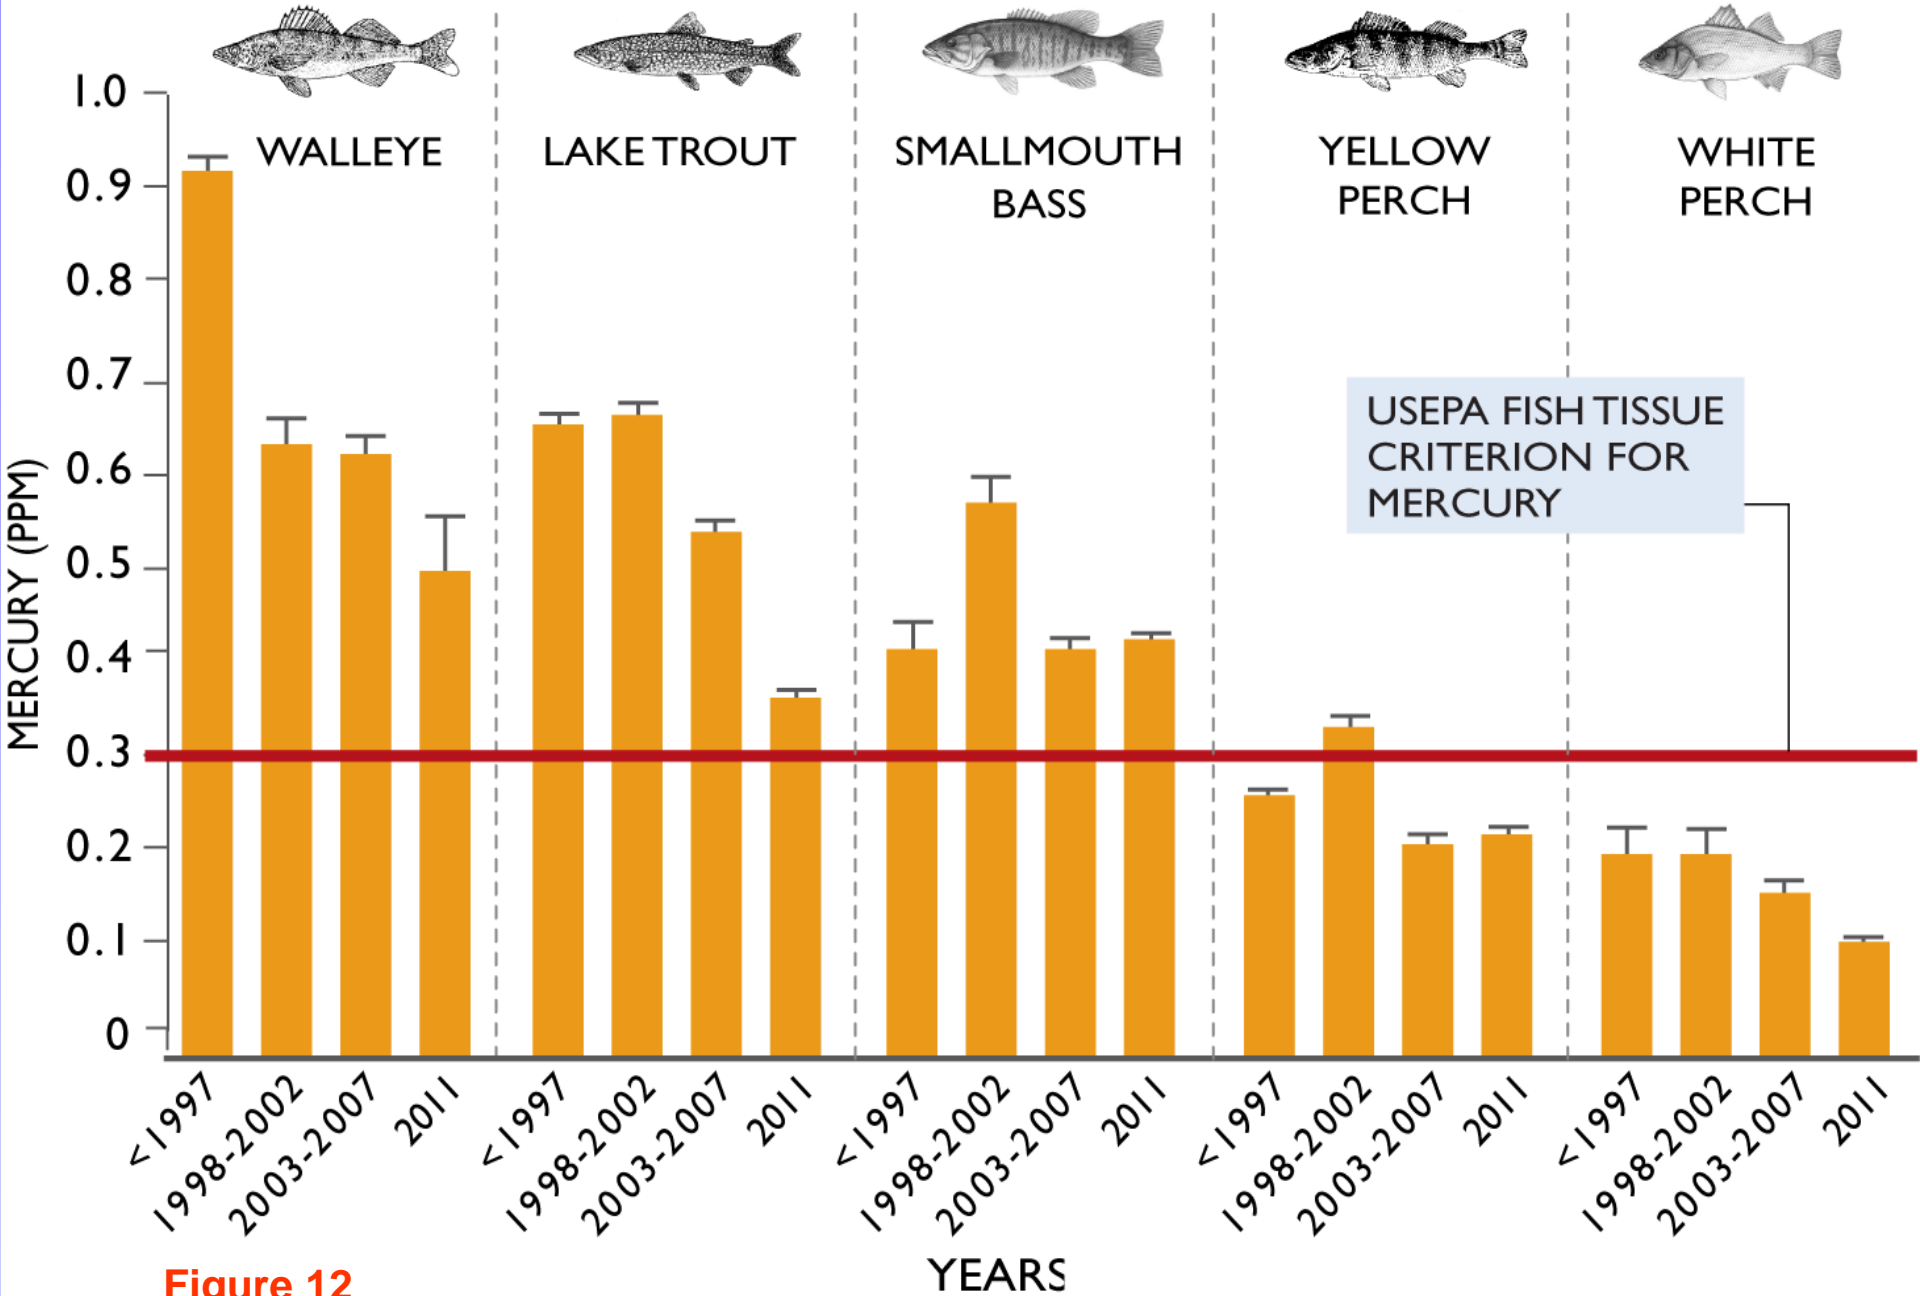
Figure 12

NOTE: The values are mean mercury concentrations, normalized to the average length of the fish. Bars show standard errors.
DATA SOURCE: Vermont Agency of Natural Resources; 2011 data from Biodiversity Research Institute.

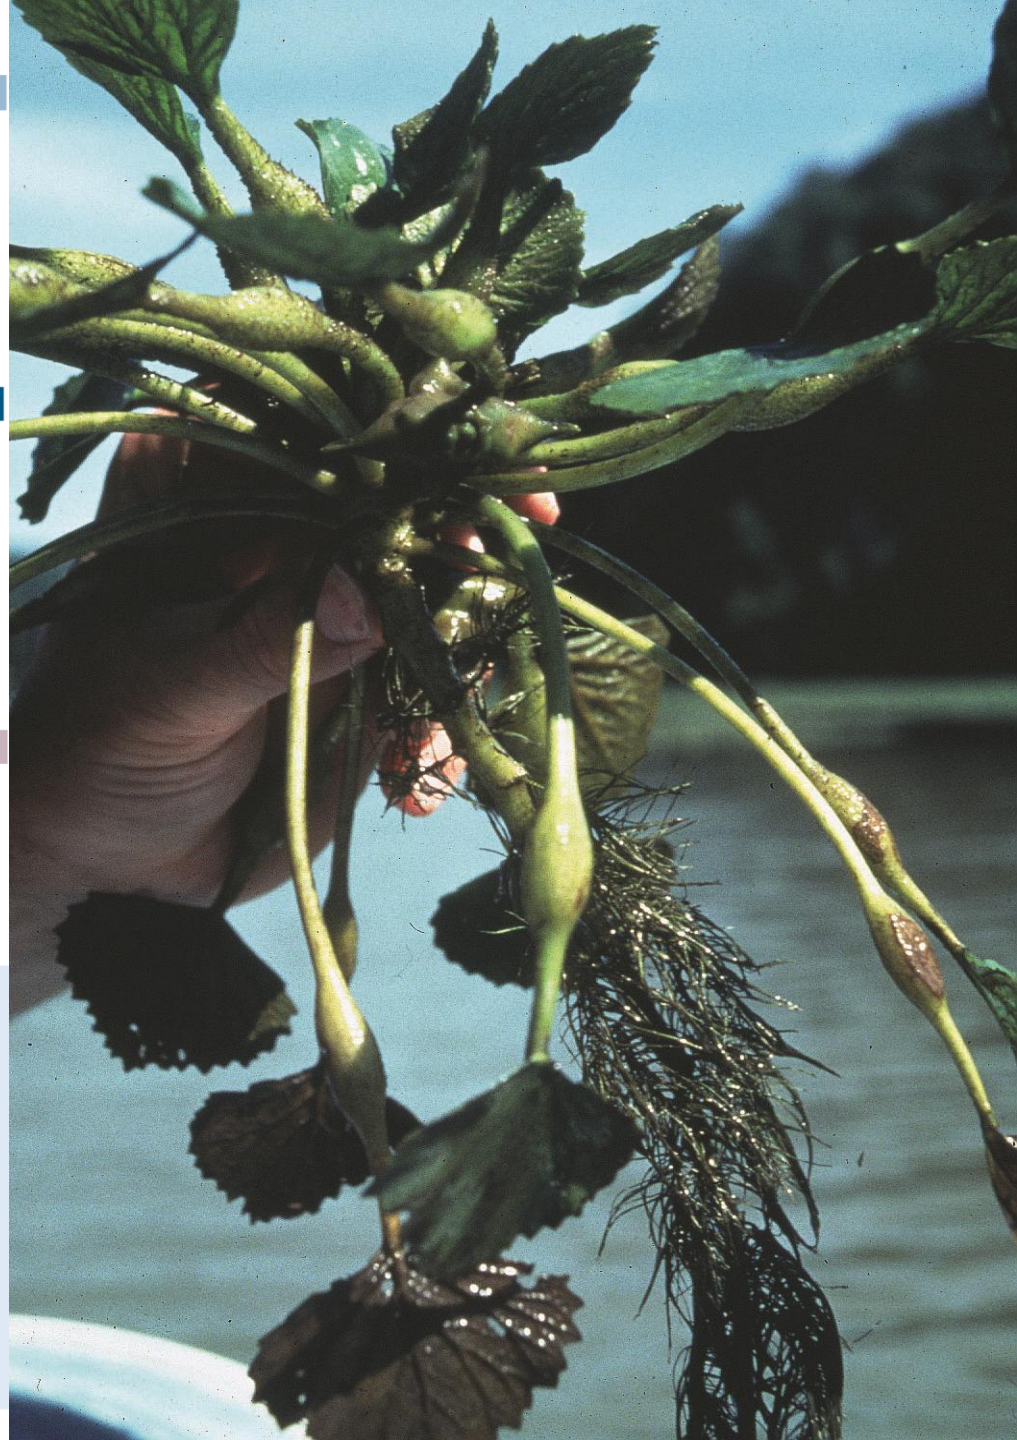
STATUS

GOOD

No water chestnut present and no management needed

FAIR

Water chestnut present with less than 25% coverage (typically managed hand-pulling)

POOR

Water chestnut present with greater than 25% coverage (typically managed by mechanical harvesting) in an area covering greater than 10% of the segment
