# The Quantification of Added Cohesion Due to Vegetation in the Mad River Valley

Sean Brennan, Jody Stryker, Arne Bomblies

The University of Vermont

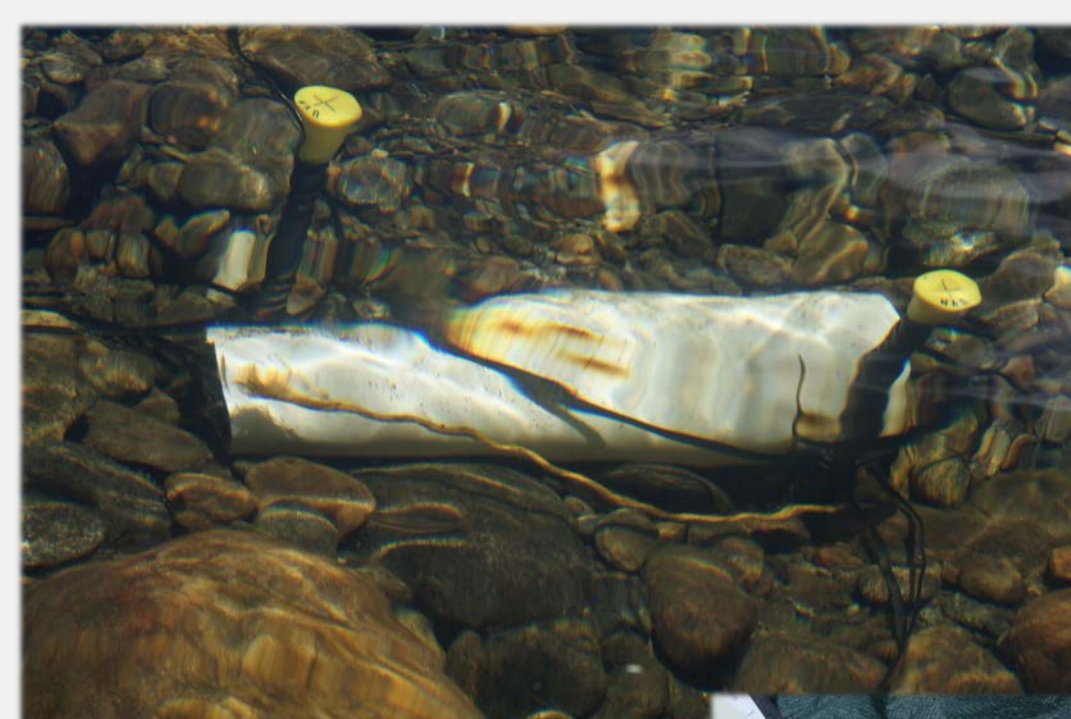
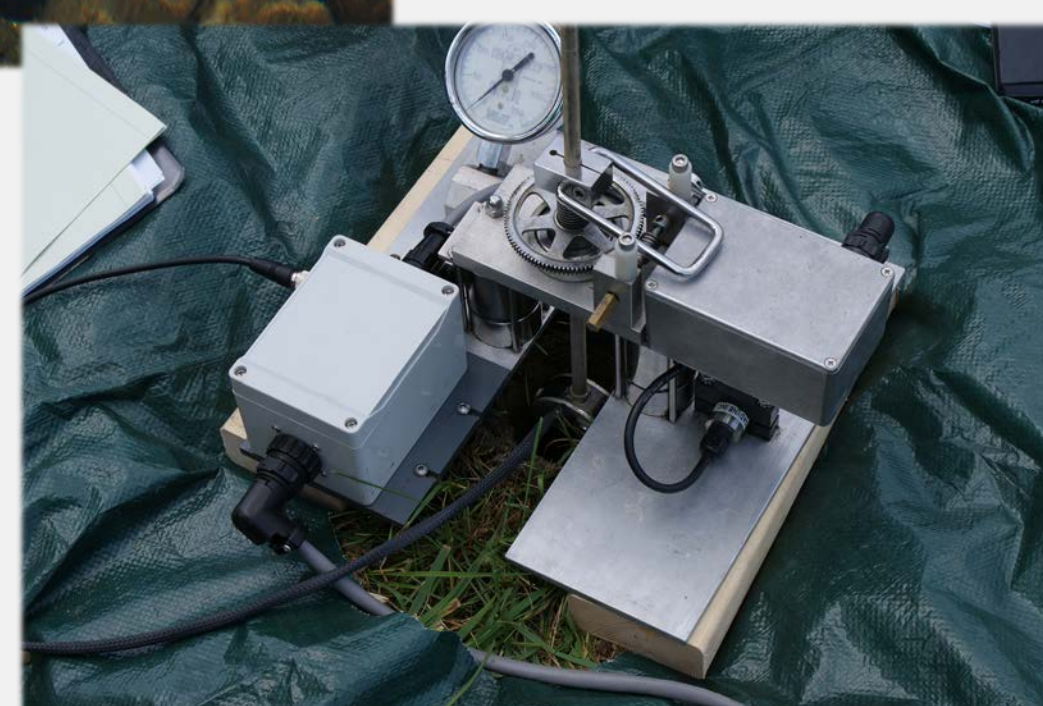
(Left) A pressure transducer is secured to the stream bed in a section of PVC pipe to safely monitor the stream height.

(Right) The BST machine sits level a top a tarp while it conducts tests.

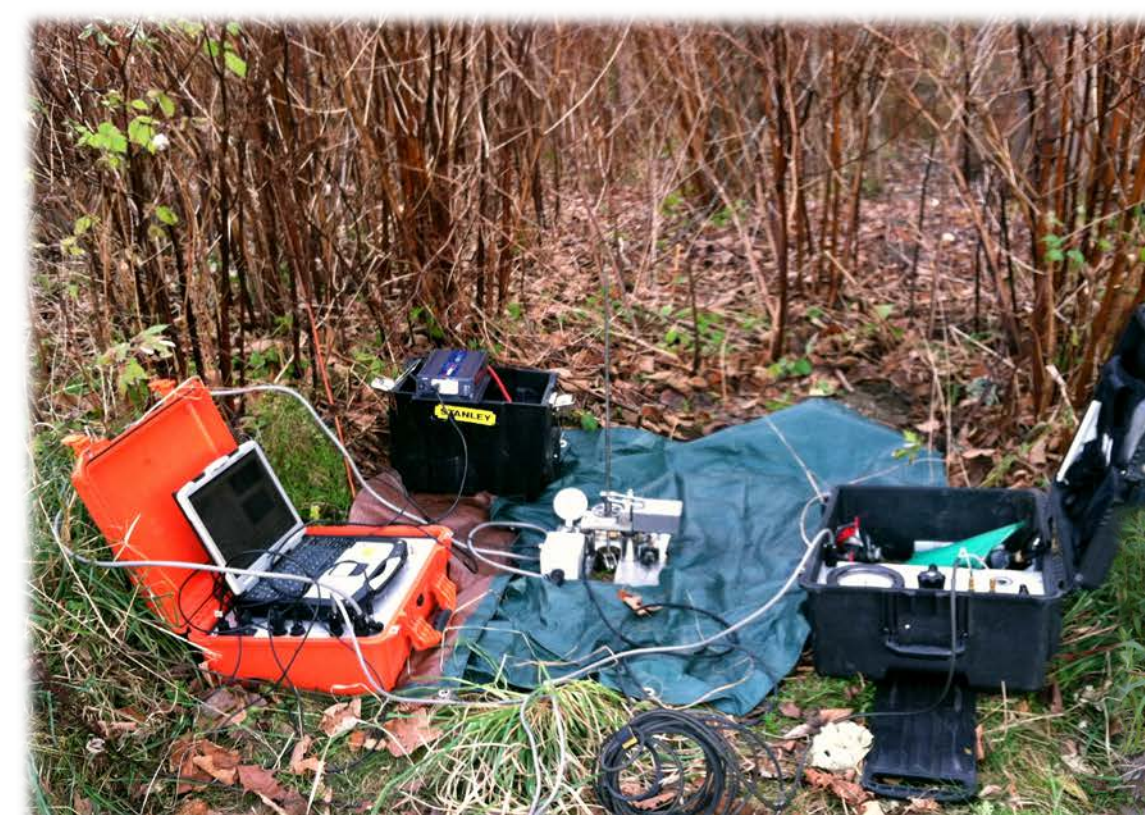
(Above) Pictured is the automated in situ BST machine mid test. The whole system includes the electronics case (orange), a portable battery, the BST machine (center), and the mechanics case (right). In the background you can see a dying grove of Japanese knotweed.

**Monitoring Soil Strength & Cohesion:** Our primary method for collecting data on soil strength and cohesion was conducting automated in-situ bore hole shear tests. This allowed us to measure soil properties on site and prevented many hours of additional laboratory work. At each test location we conducted two BSTs, the first at approximately one foot deep and the other at about three feet deep. This was done with the notion that the majority of plant roots extend to a depth of two feet, leaving soil at the three foot depth to be generally undisturbed<sup>2</sup>. Test location was based on proximity to the Mad River, vegetation, and land use type. To simplify the selection, we labeled each test site one of four land use types: forest, field, pasture, and Japanese Knotweed. At the site of each test, we also took three tensiometer readings in order to quantify pore pressure.

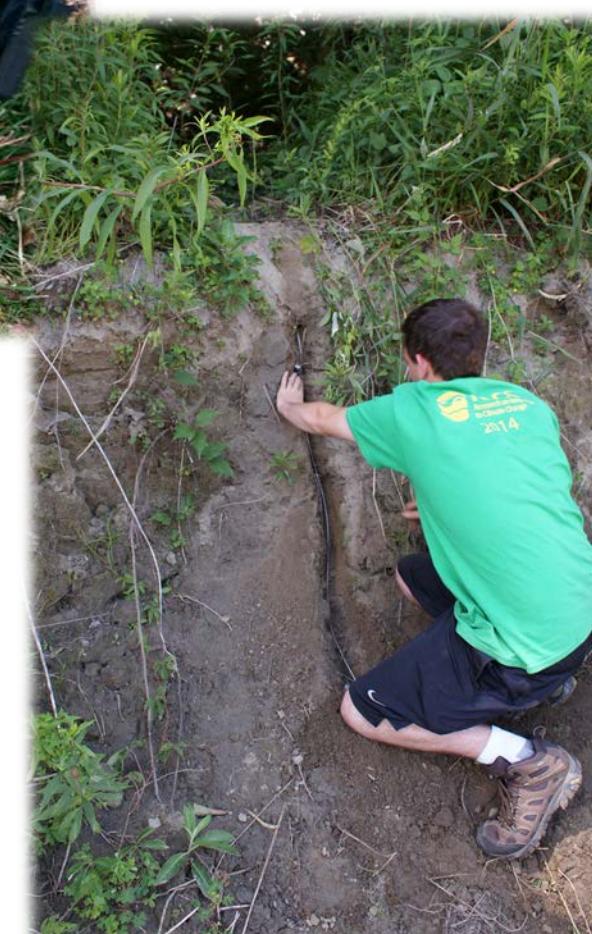
(Left) Here I am installing accelerometers on a stream bank that was displaying weakening conditions.

**Tracking Stream Bank Failures:** In order to track stream bank failures related to vegetation/land use type we used a system of accelerometers, monitoring wells, and pressure transducers planted in the stream. The aim of the set up was to compare the levels of water in the streams and the stream banks in order to correlate them to the times at which stream bank failures occurred.

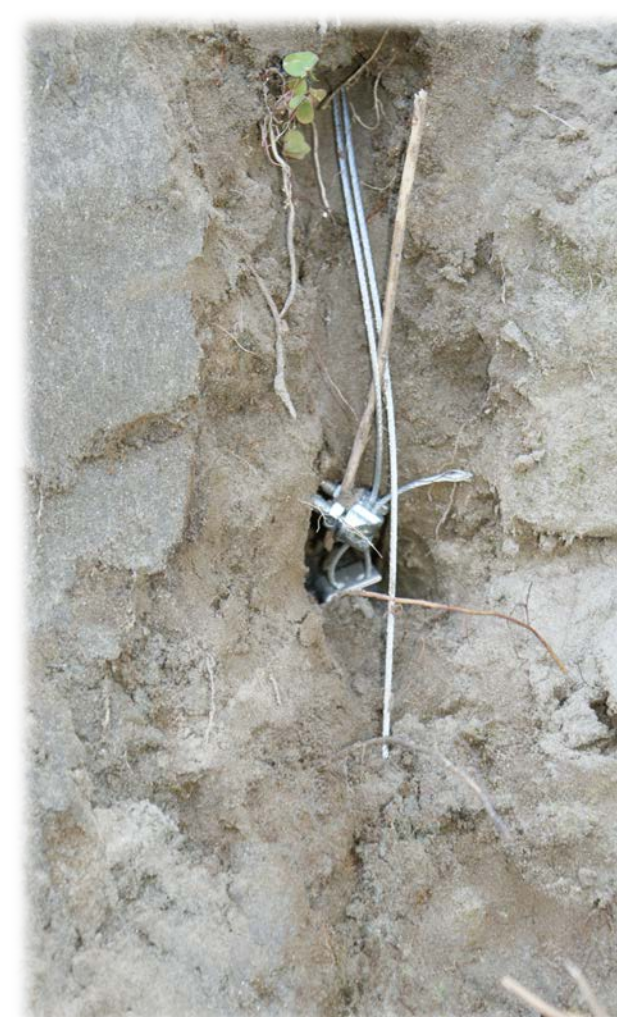
(Right) A closer detail of an installed accelerometer before it is again covered with soil.

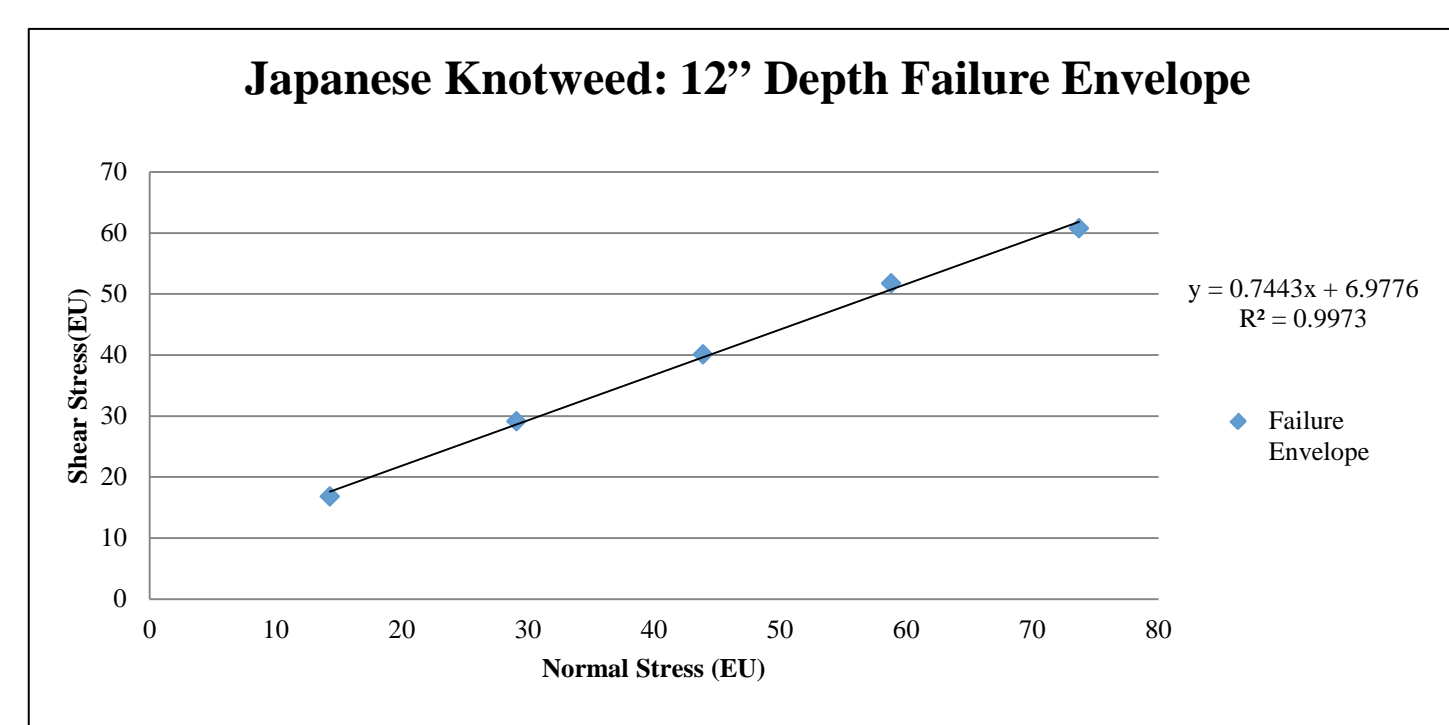
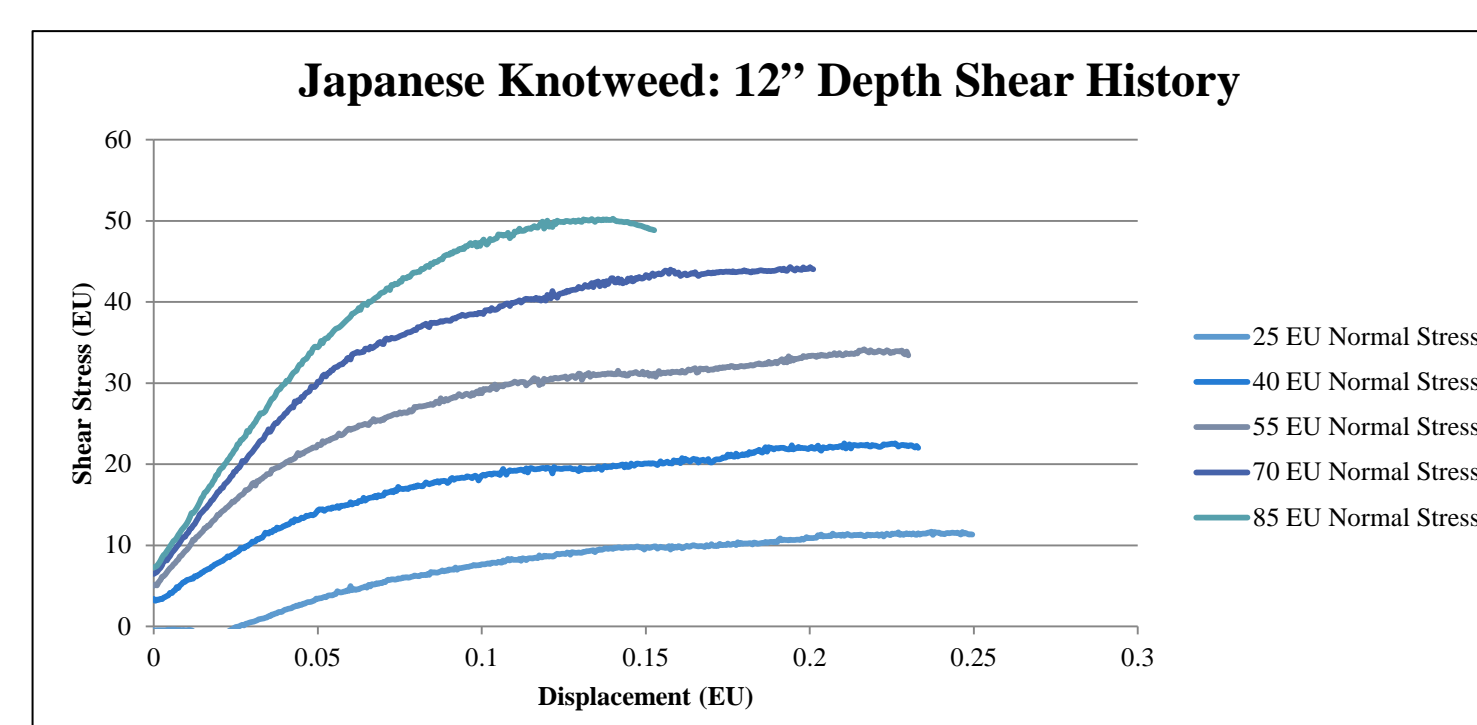
**Sample Test Results:** Pictured left are typical results produced by a successful BST test. The graph on the far left demonstrates the soil shear strength when subjected to varying normal stress levels produced by the device. The shear history graph shows the shear stress being absorbed by the soil during the five applied normal stresses. The final applied stress (85 kPa) produces a clear indication of the soil's maximum shear stress, 50 kPa. This particular test also concluded that this particular soil has a friction angle of 33.6° and a cohesion factor of 2.545.

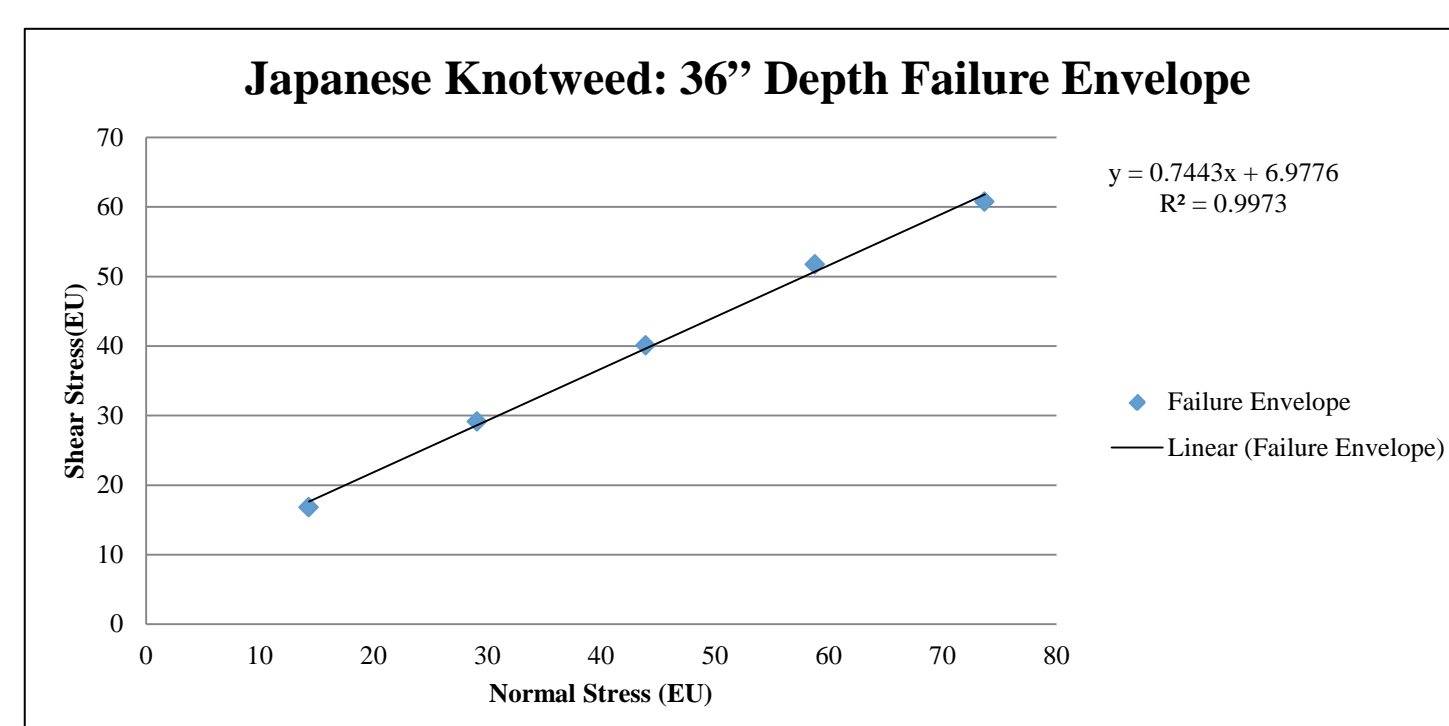
(Above) The graph above is the result of a second BST test conducted in the same borehole as the previously pictured test but at a depth of 36" instead of 12". It produced a cohesion factor of 6.99 and a friction angle of 36.5°.

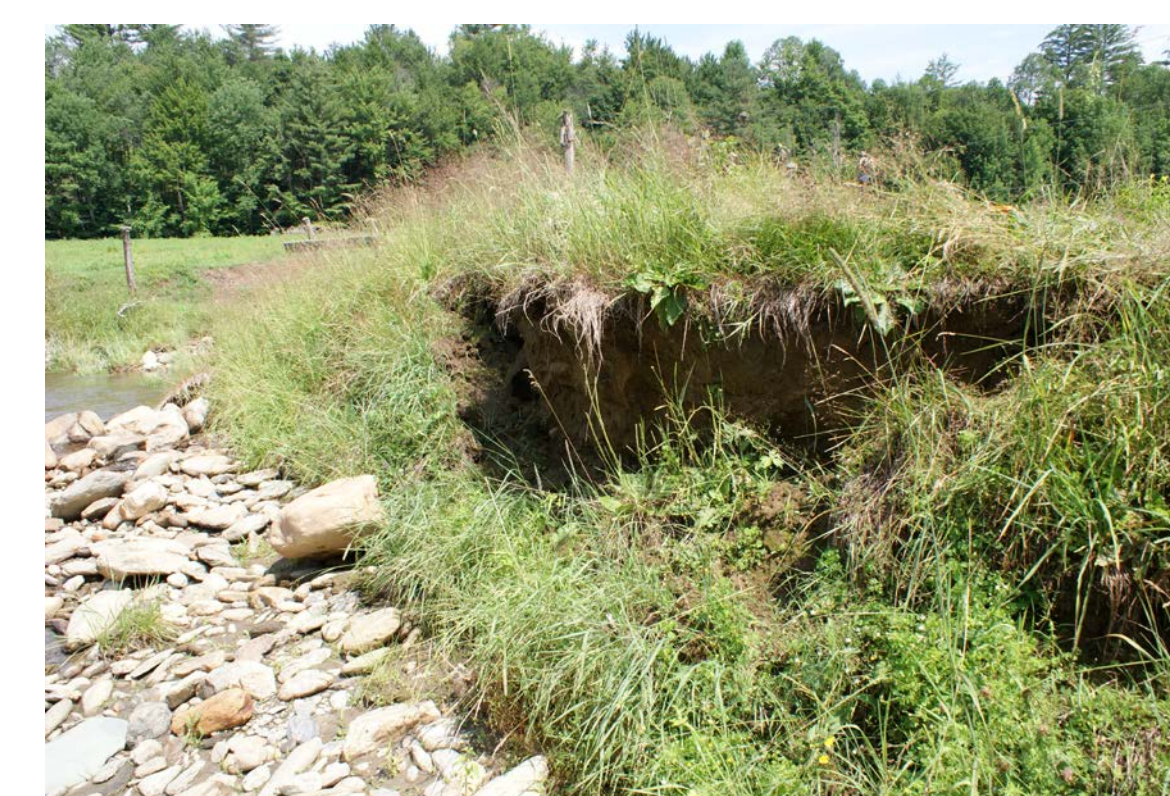
(Right) Pictured here is the sole stream bank failure we captured during the project's field season. It is located on the edge of a pasture (Reynold's Farm in Waitsfeild, VT).

As mentioned earlier, we also planted accelerometer set ups in four stream banks along the Mad River. Unfortunately, due in part to low levels or rain this past summer we only caught one failure. Thanks to our monitoring well and in-stream pressure transducer, we concluded that the failure was not due to a rise in stream level, but more likely due to the increased weight of soil after a small rain event, which was accompanied by a slight rise in ground water levels in the bank. However, because this was our only failure we were unable to relate its probability to the local vegetation of land use type.

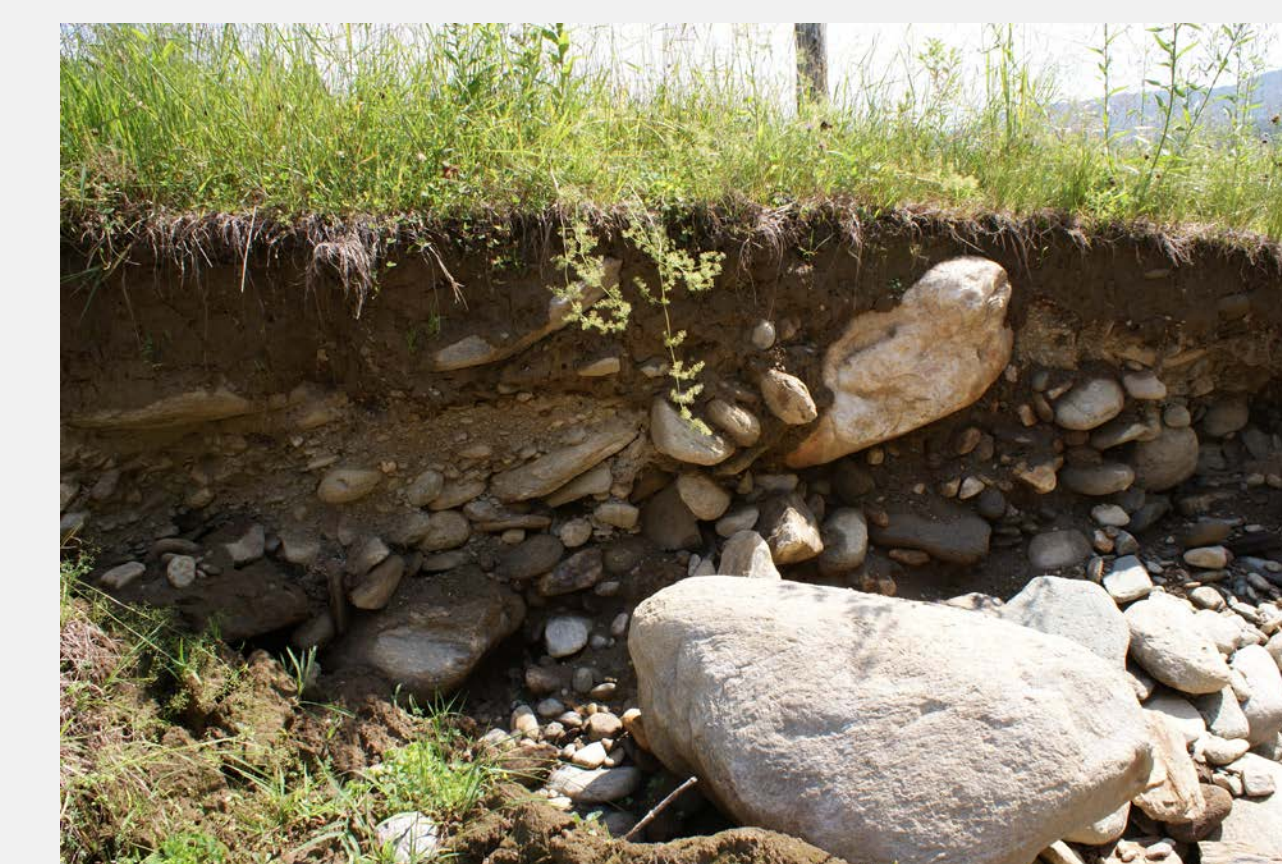
(Left) High levels of rock and gravel consistently prevented accurate strength tests to be conducted in areas of interest.
