# Quantifying Sediment and Phosphorus Loading from Streambank Erosion using LiDAR Scanning

Hanna Anderson  
University of Vermont

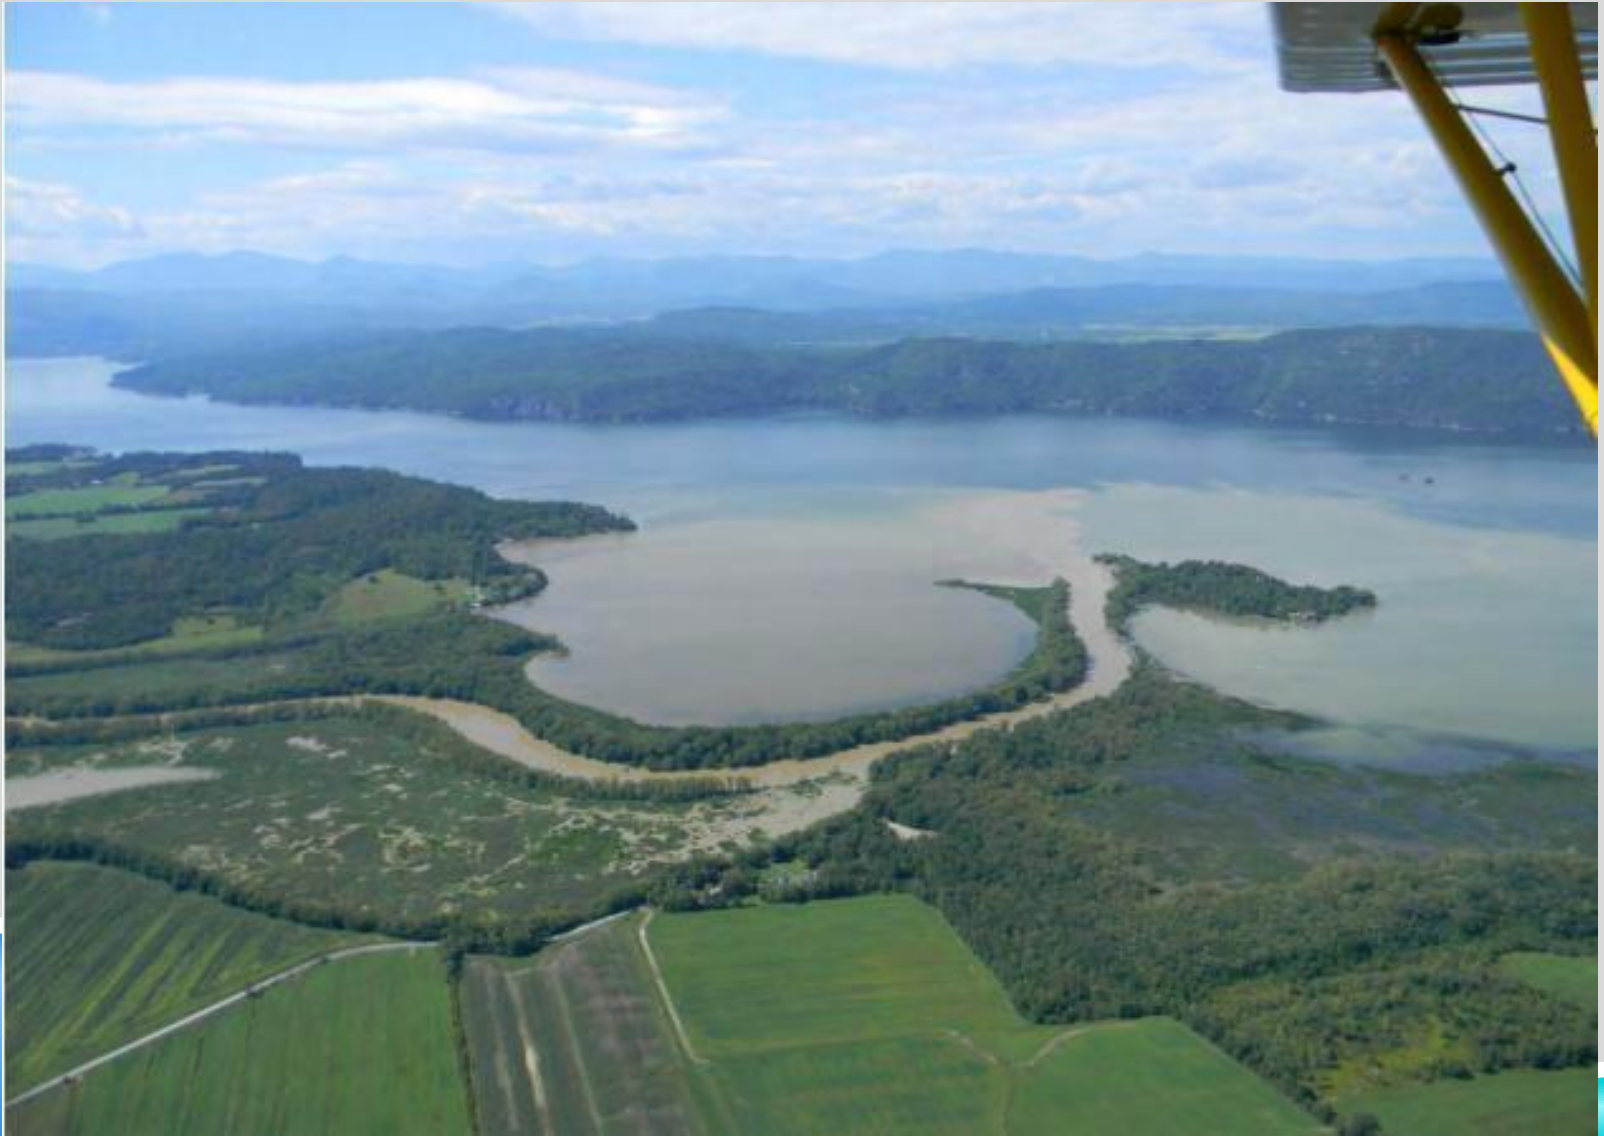
# Sediment Plume from Otter Creek entering Lake Champlain after Hurricane Irene

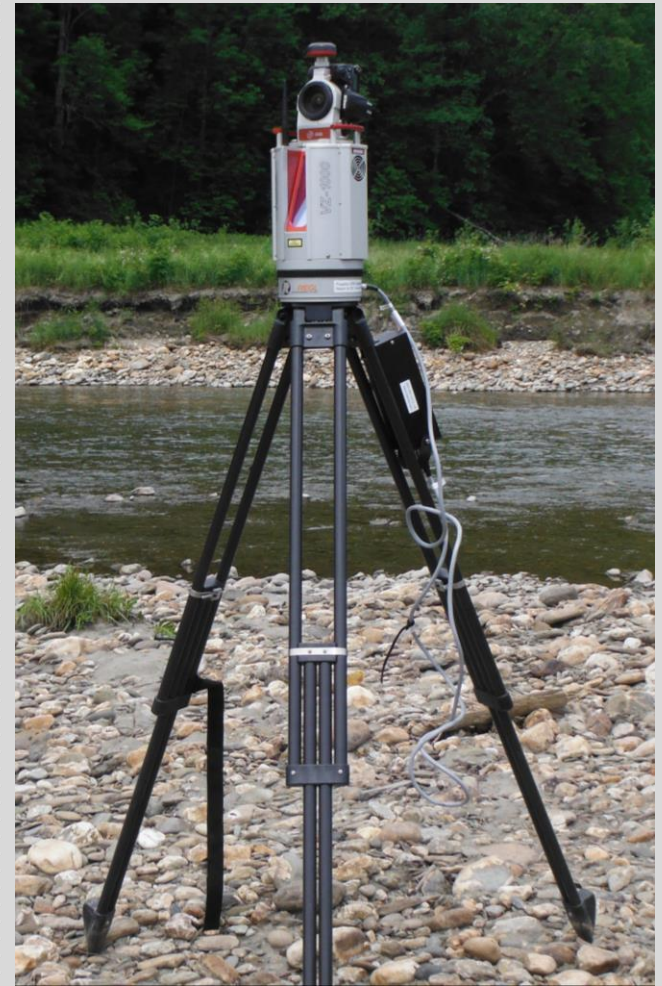
# 3D Terrestrial Laser Scanner

## LiDAR: Light detection and Ranging

- Infrared laser beam
- Rotating mirror
- GPS receiver and camera

## Technical System

- Echo Digitization
- Ranges up to 1400m
- High resolution with  $<0.1$  cm accuracy

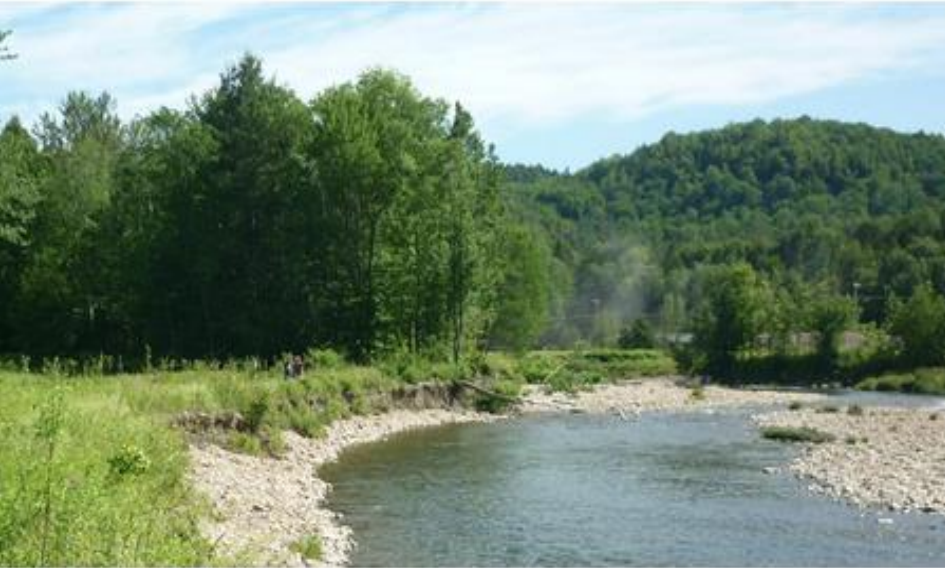
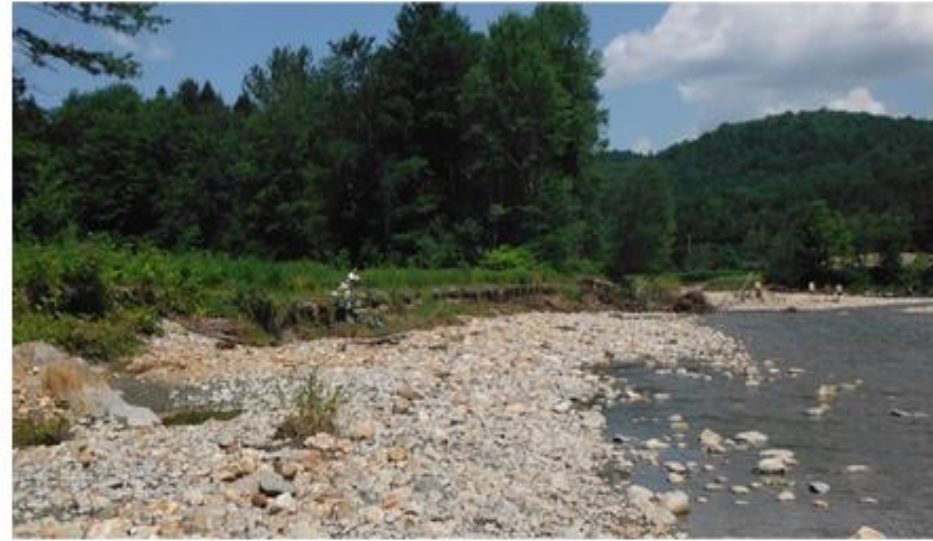
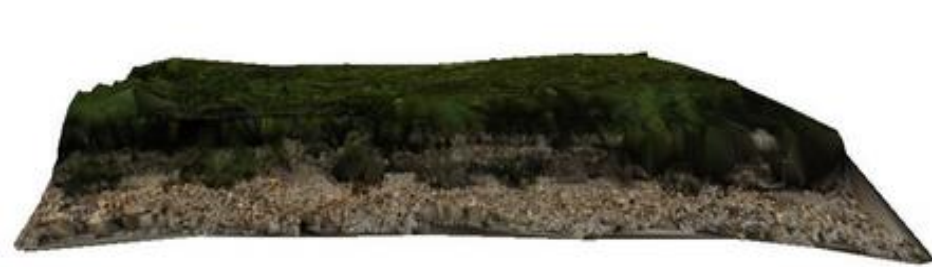
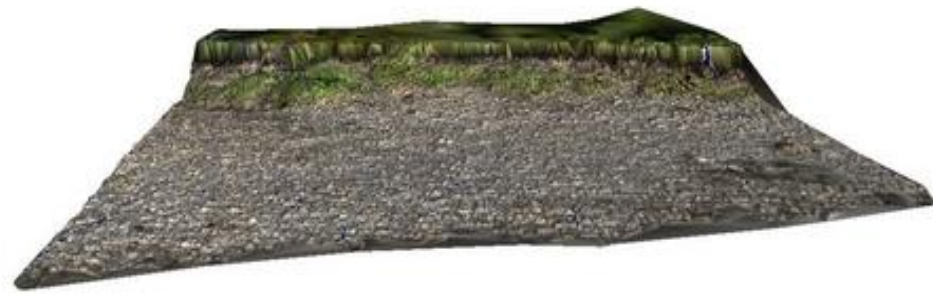
# LiDAR Results

Streambank prior to July 3-4, 2013 storm

Streambank after the July 3-4, 2013 storm
