# Lake Champlain

## Monitoring and Assessment to Understand Lake Champlain and its Tributary Lakes and Streams

Monitoring, Assessment and Planning Program  
VT Dept. of Env. Conservation – Water Quality Division

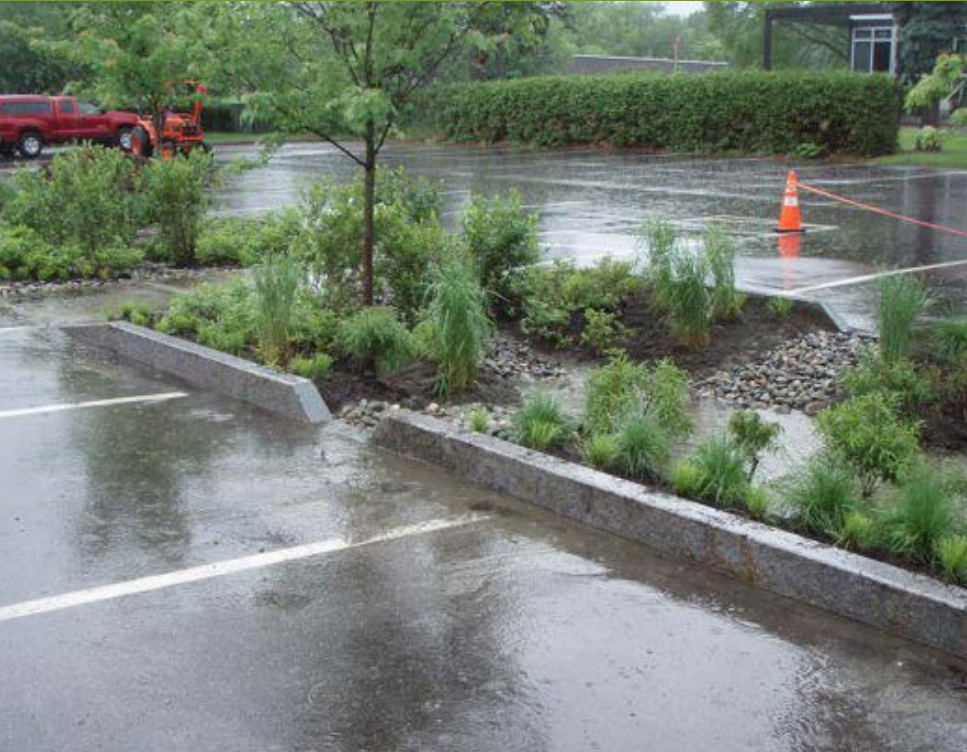
Green stormwater  
infrastructure, Montpelier

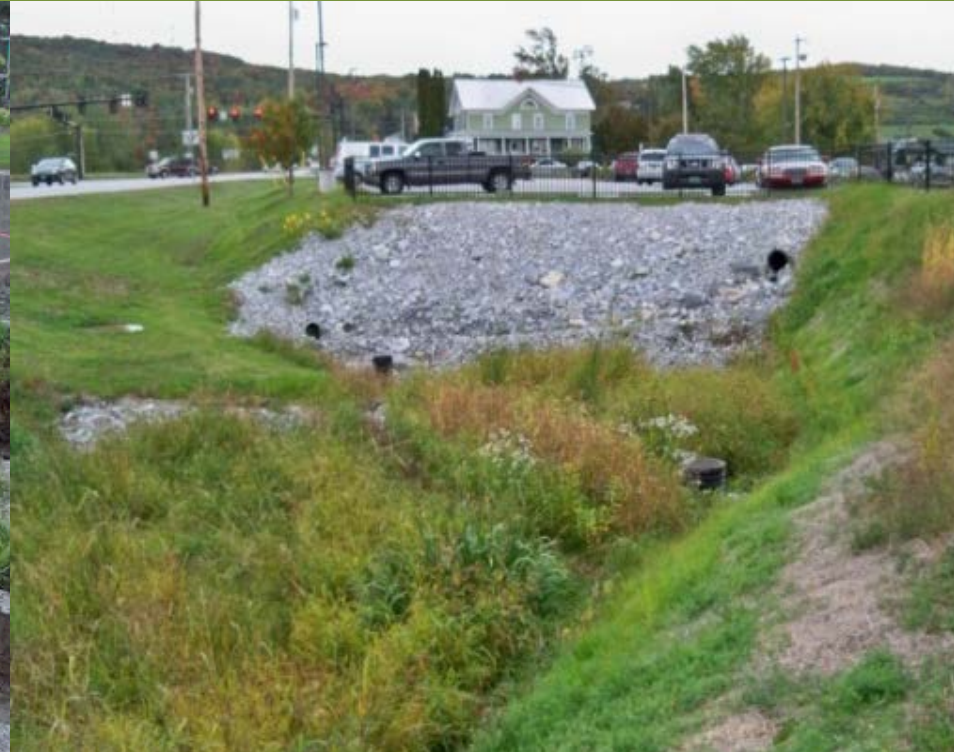
VTrans/VDEC constructed  
gravel wetland, St. Albans

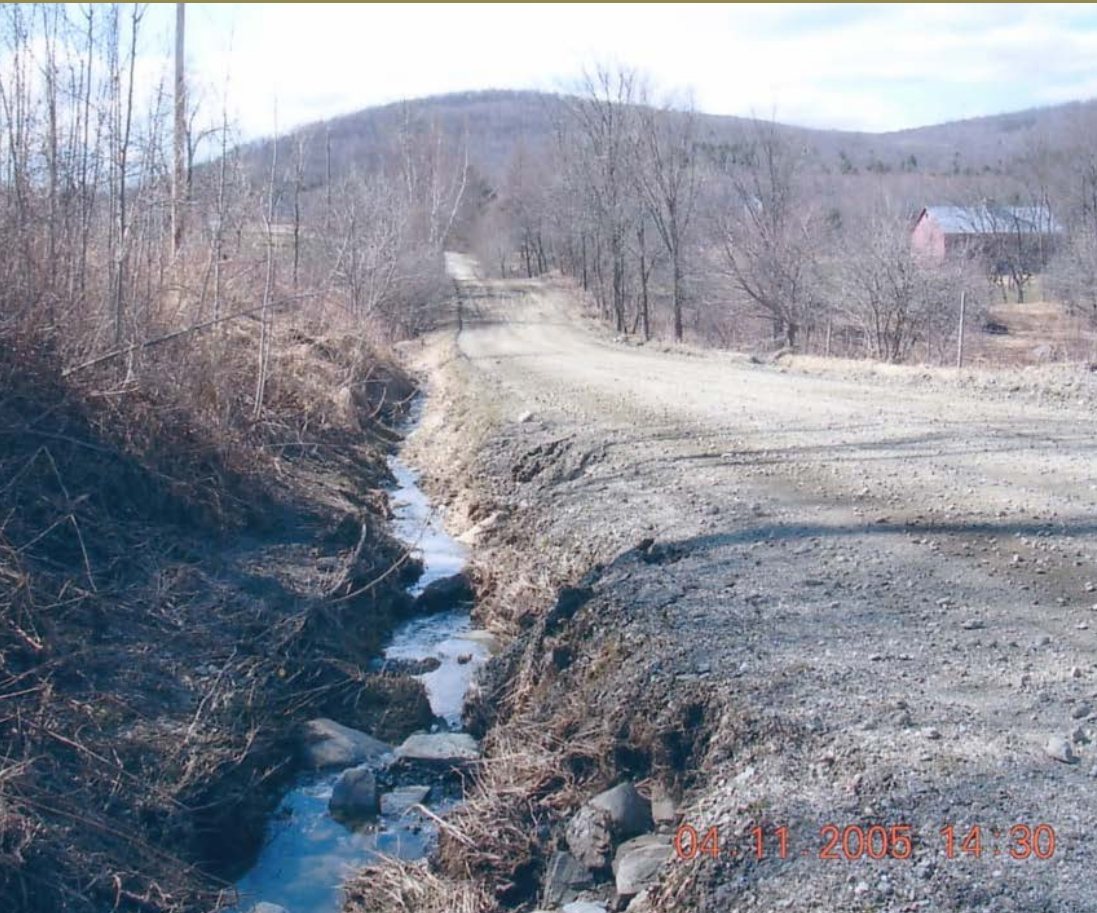
Eroding roadside ditch

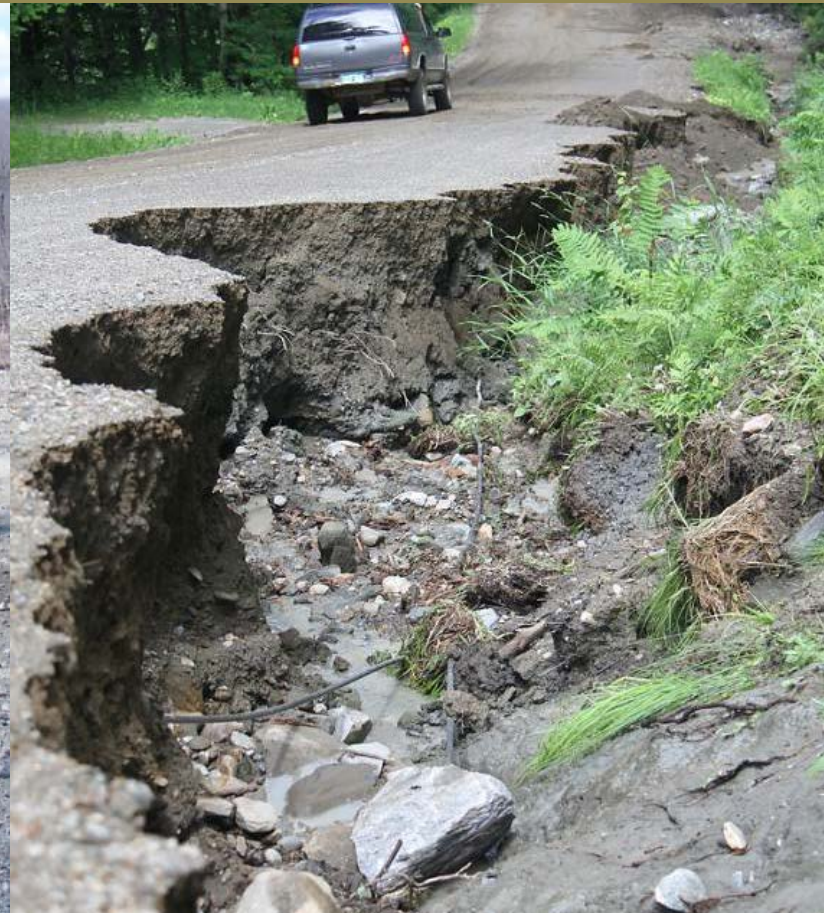
Storm-damaged gravel road

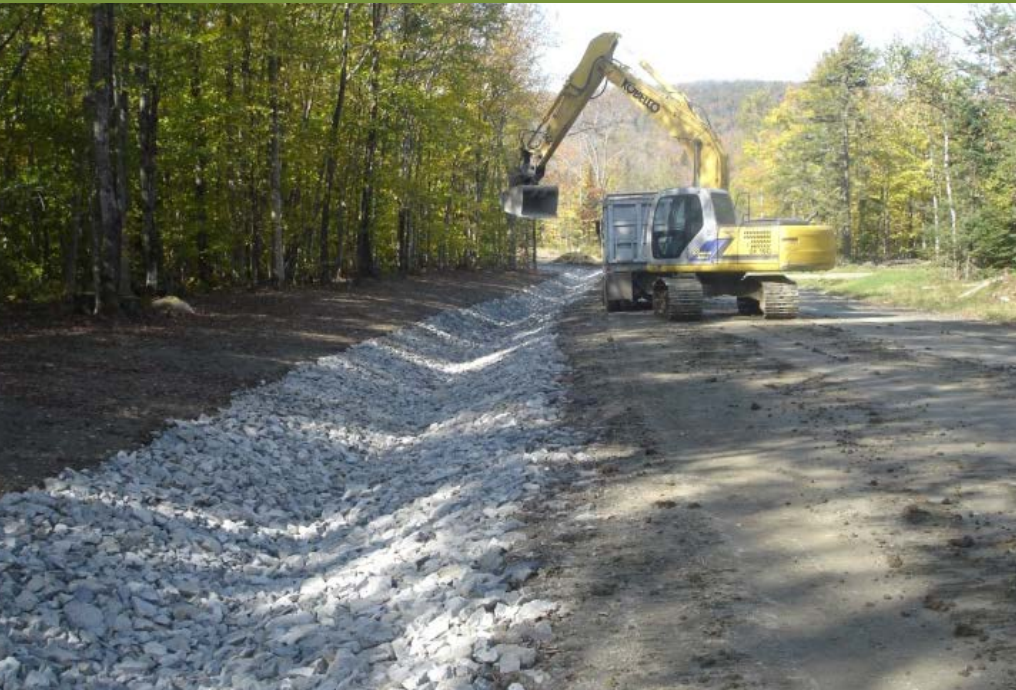
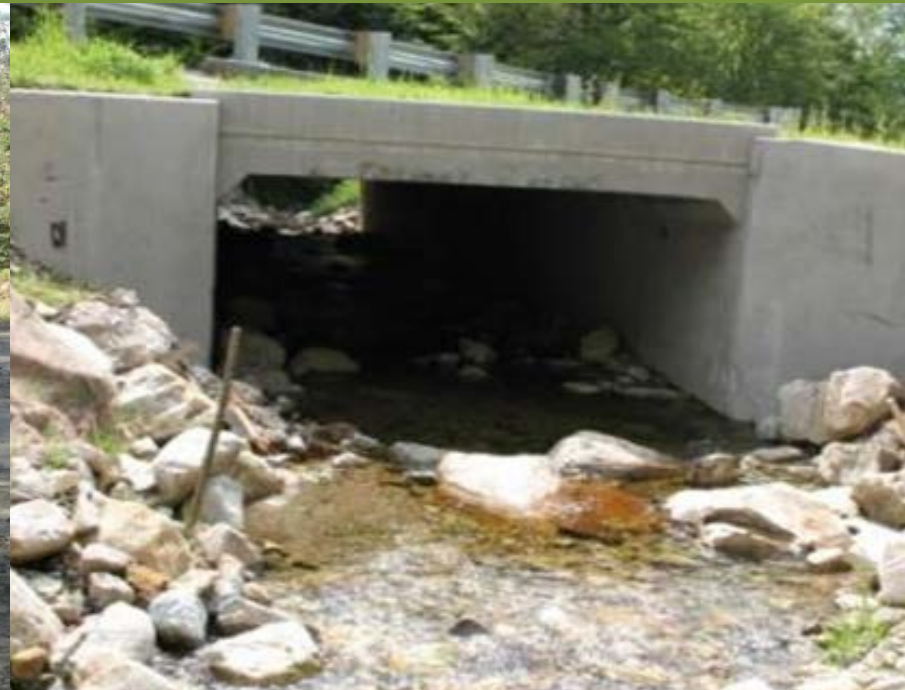
Vermont Better Back Roads-funded drainage and culvert projects

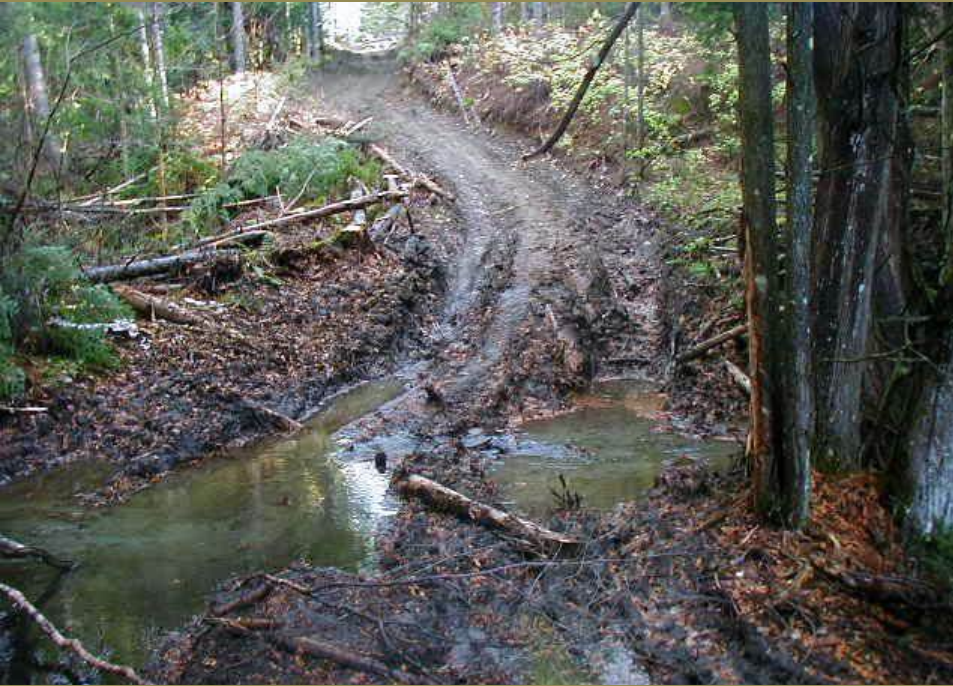
Poor stream crossing at logging job

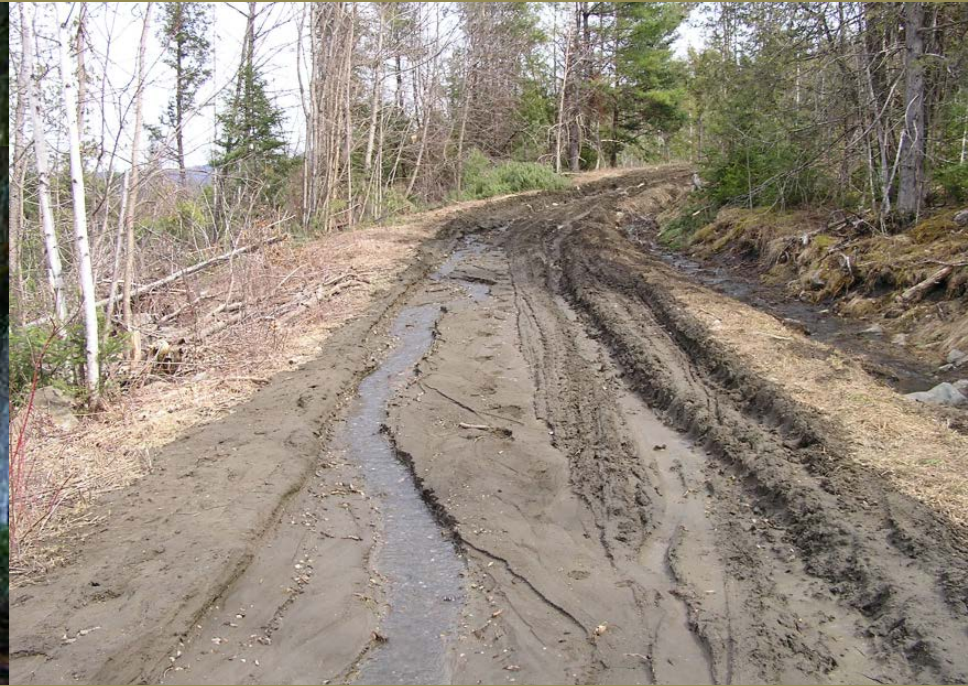
Poor management of drainage along logging road

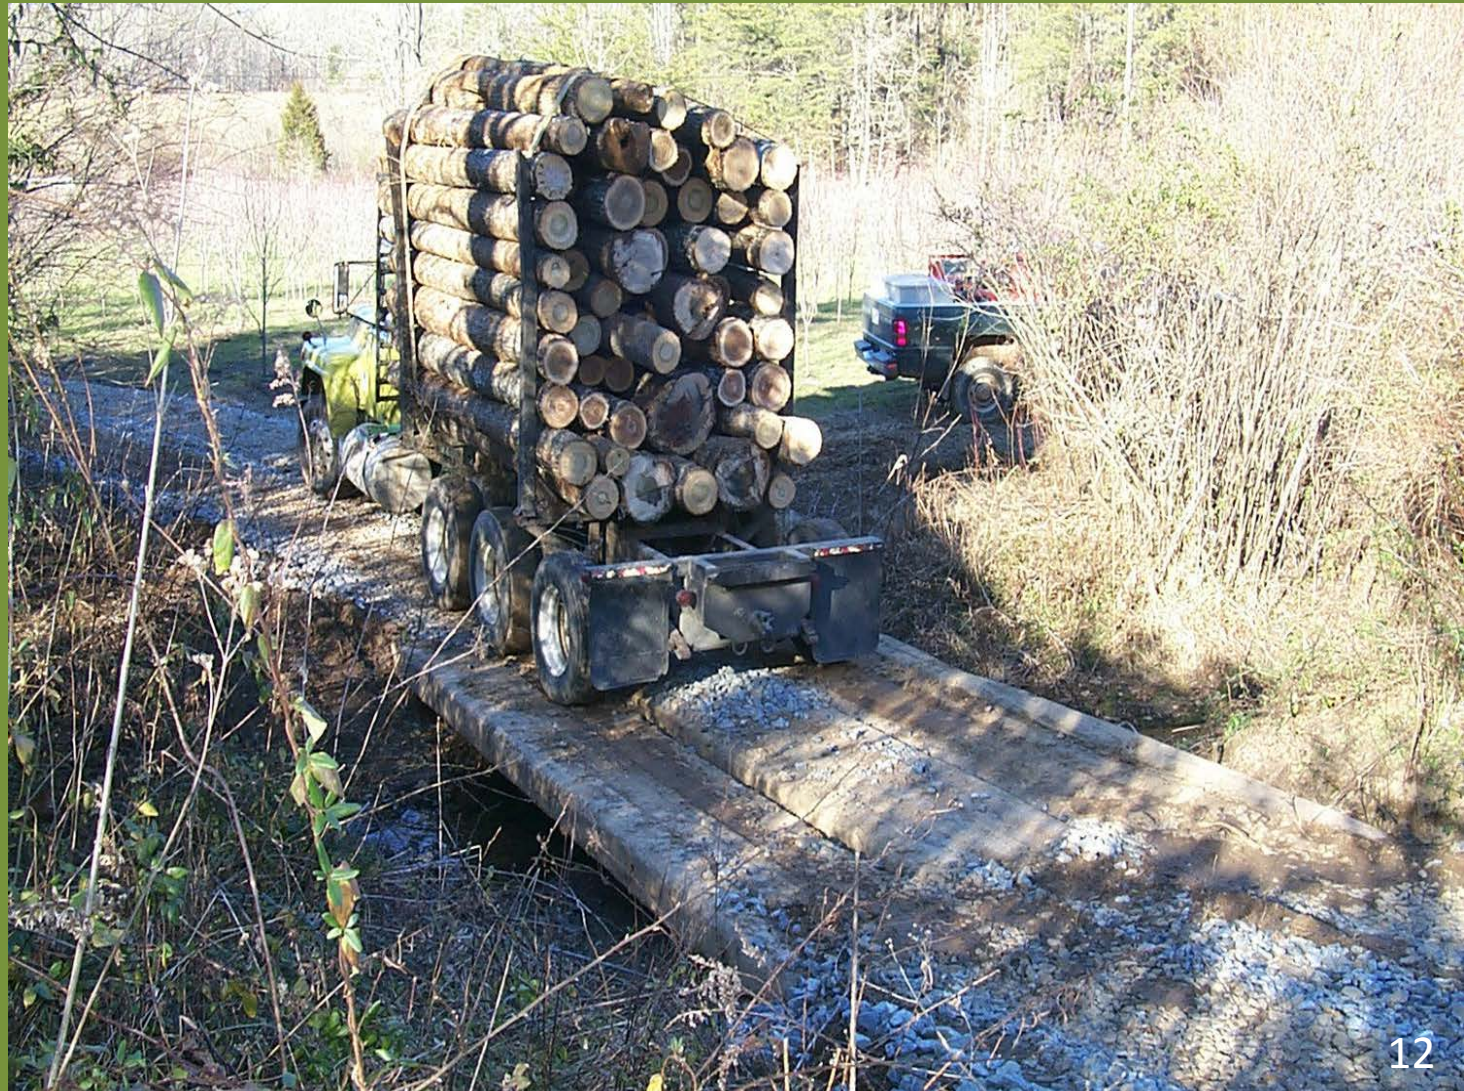
Temporary  
stream  
crossing  
along  
logging  
road

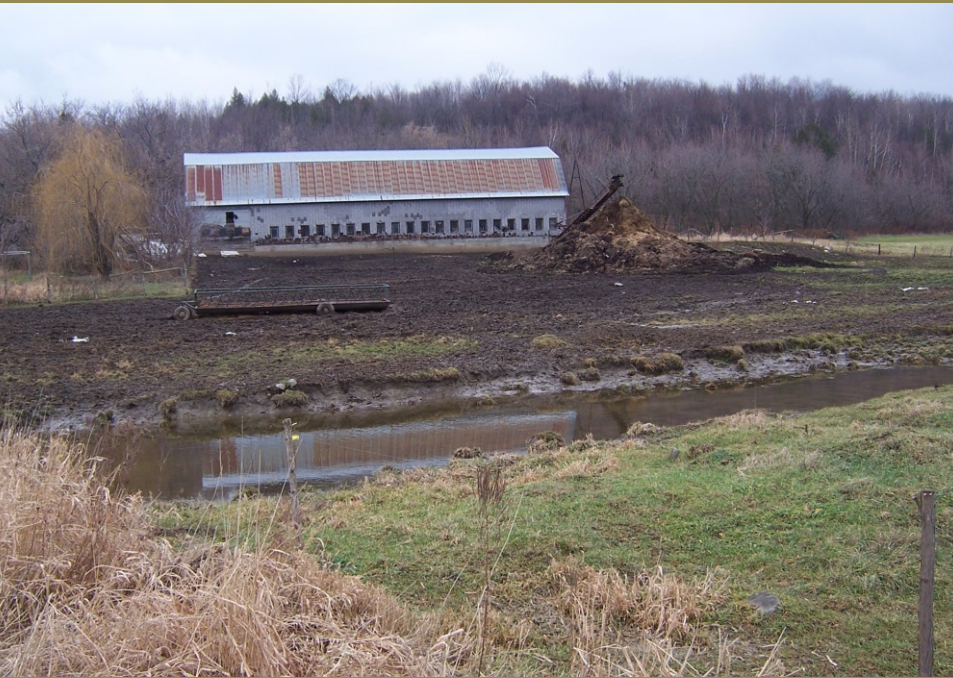
Impacts from  
livestock access

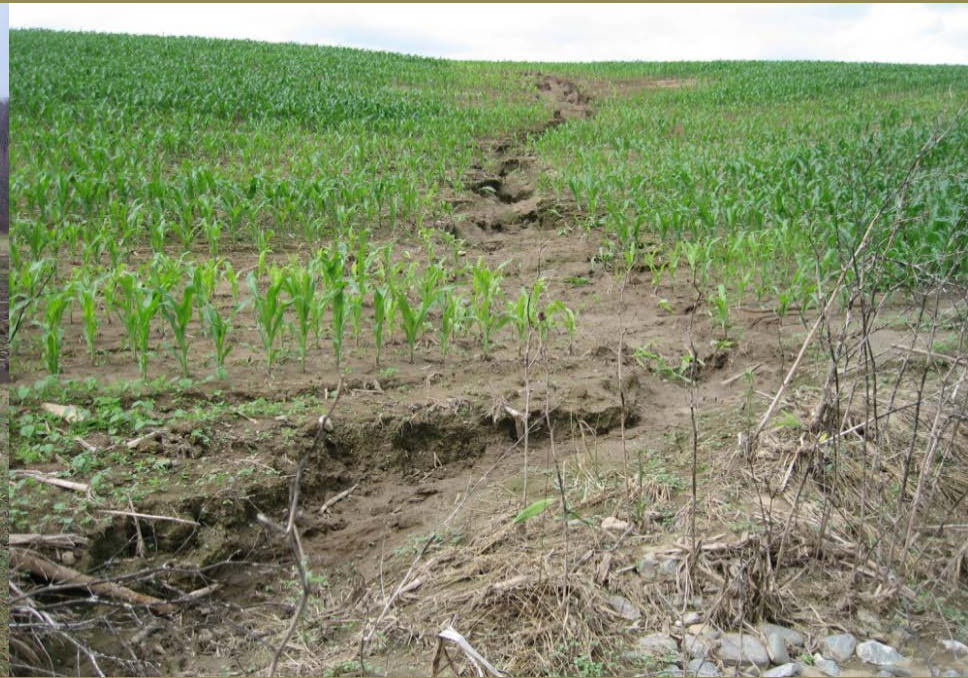
Eroding gully

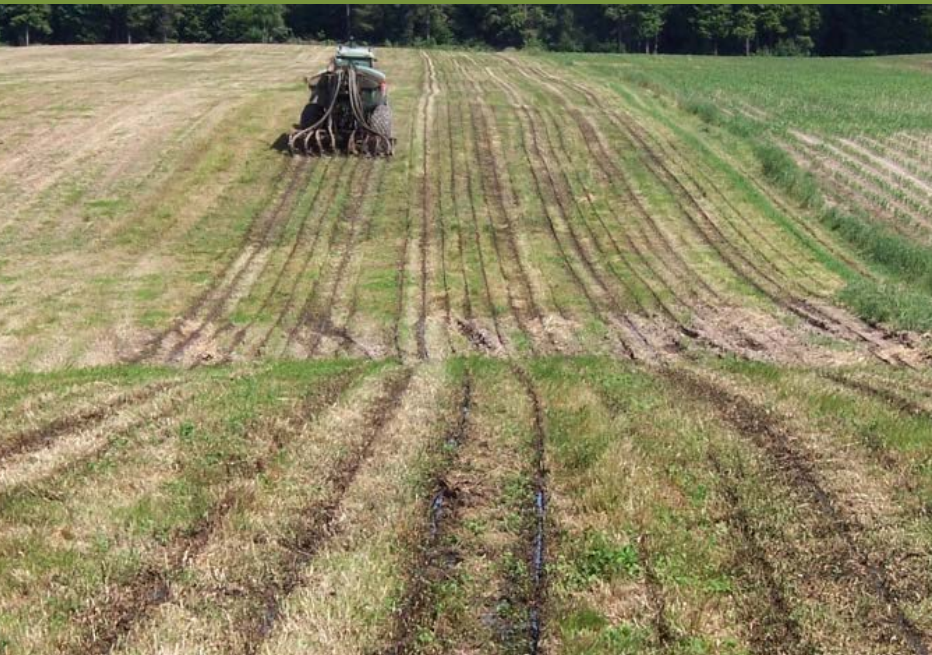
Manure injection

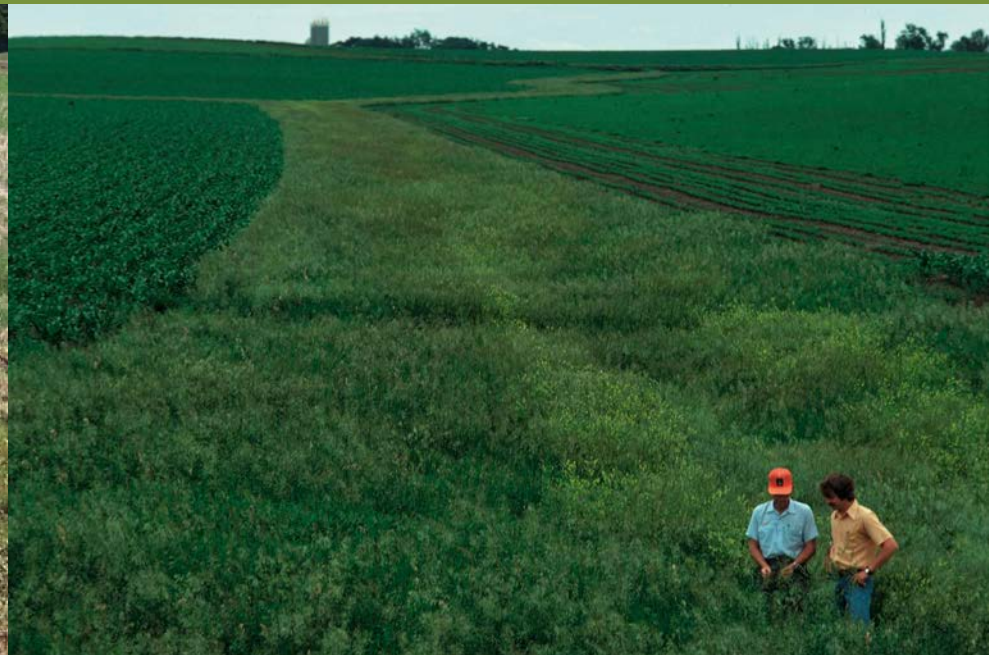
Grassed waterway  
to prevent gullying

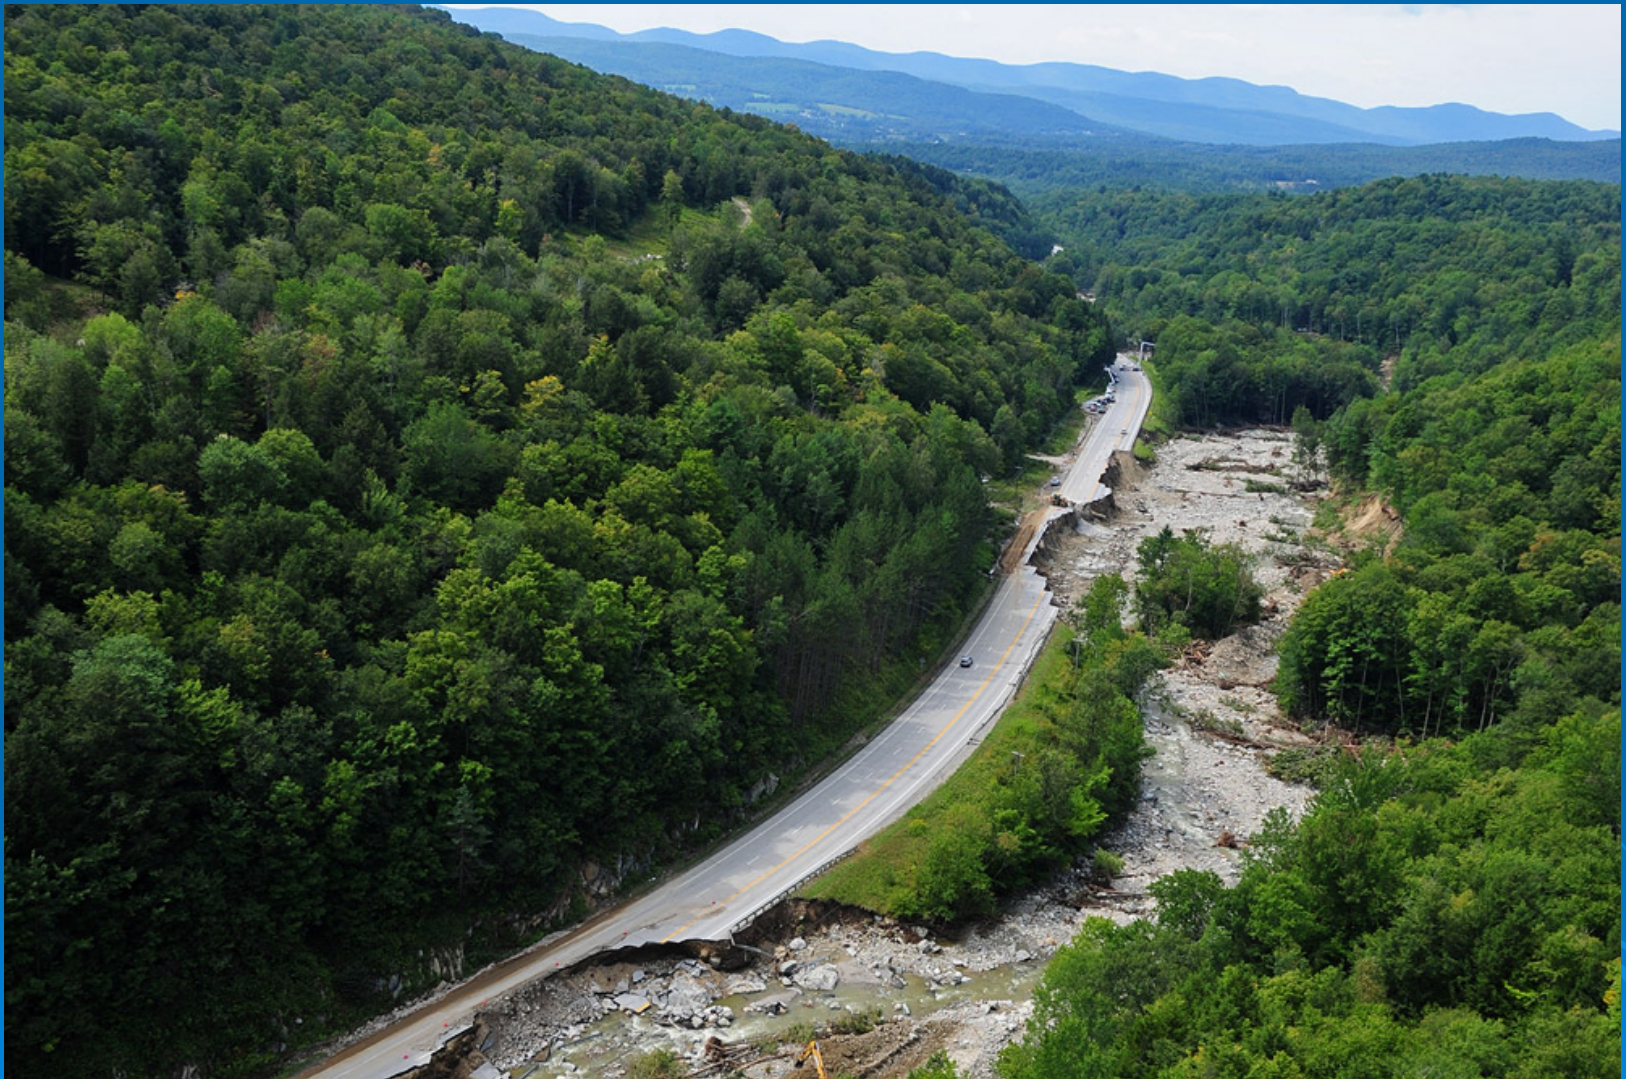
# Mendon Brook recreated some meanders

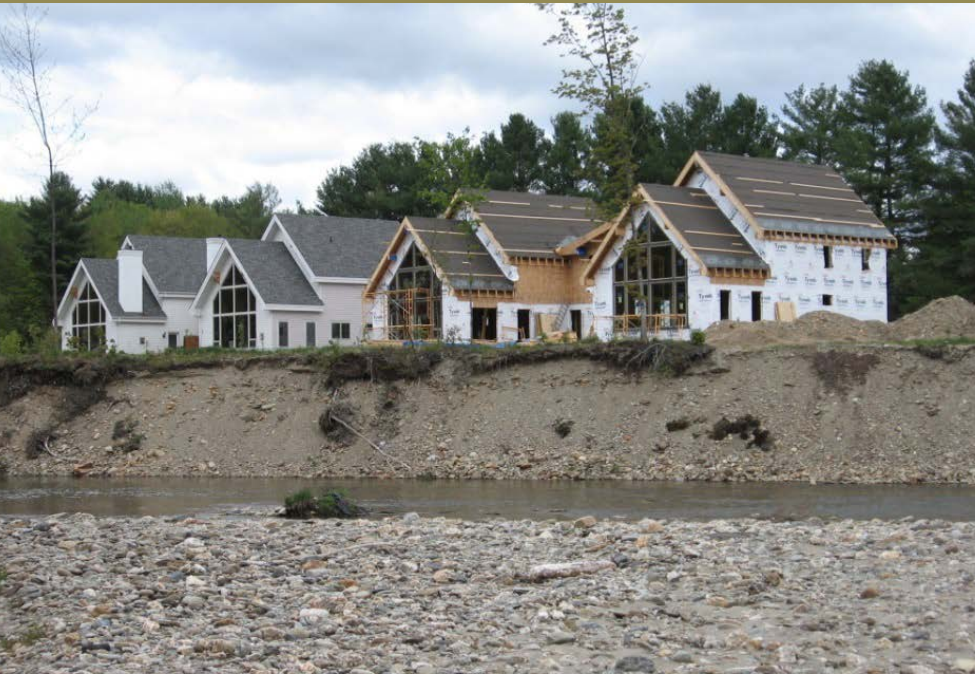
Floodplain development

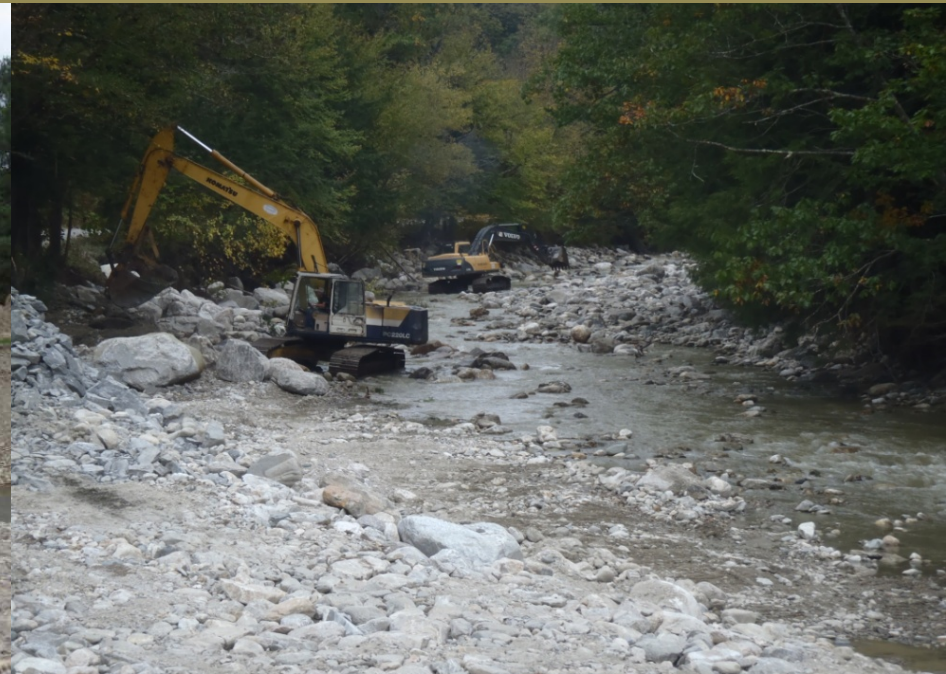
Channelization
